Investigation And Analysis of a Fatal Occupational Accident

N.Chenouf and W. Benhassine

Occupational Health Service

University Hospital Center Batna, Algeria

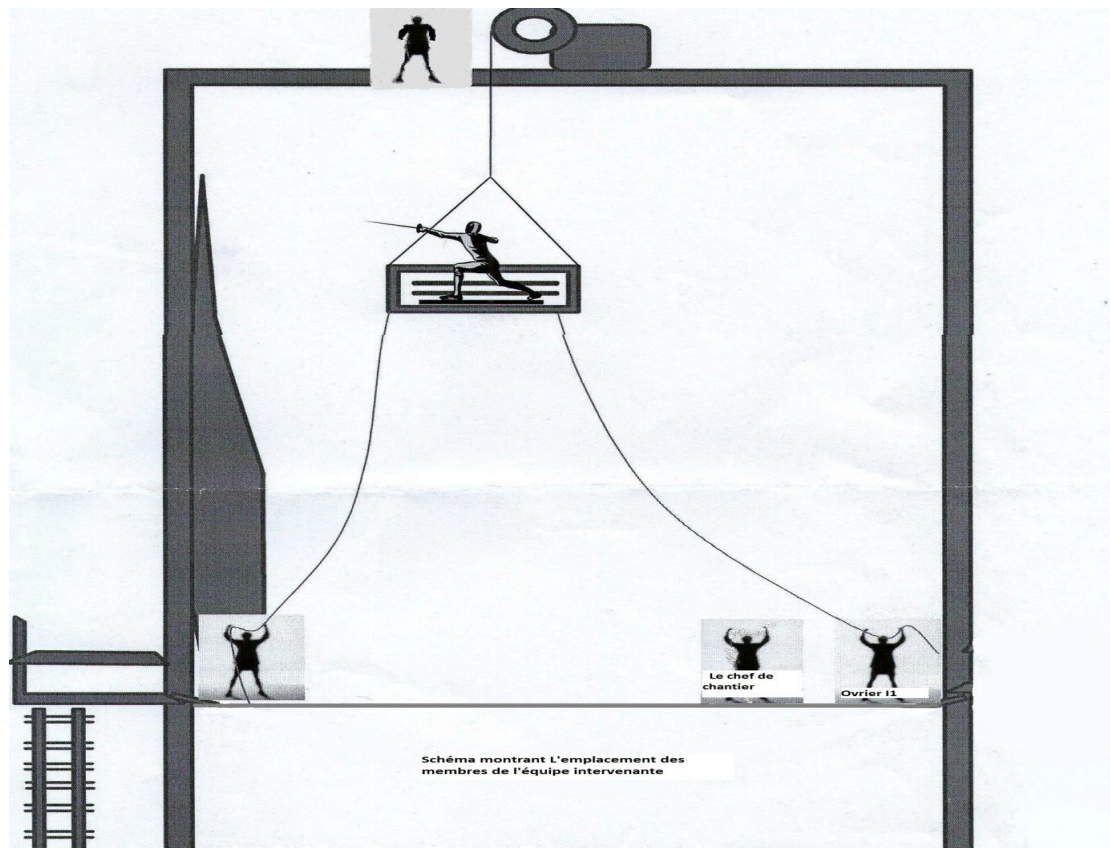
- Cement stuck to the walls for 03 years, the former director did not establish an agreement with a cement silo maintenance and cleaning company.
- Maintenance and cleaning of the silo was started by another company (Company A), which caused cracks to appear in the cement stuck to the walls of the silo.
- Company A fell behind schedule to complete the operation which led the cement plant to terminate the agreement.
- The remaining work was contracted to Company B.
- An assessment of the remaining work volume was done by the company supervisor and crew leader.
- The crew leader considered the remaining work easy to carry out. Figure 1 showing the location of the response team members at the silo (Figure 1 and Figure 2).

Figure 1. The location of the response team members at the silo

The accident occurred at 8:20 am where a crew consisting of a crew leader and four workers employed by a cement silo maintenance and cleaning company (Company B) started work at 6:00 am. Their activity consisted of dislodging the hard cement stuck to the walls of a silo which had caused the extractors to clog. This operation had been started by another deburring company (Company A), which caused cracks to appear in the cement stuck to the walls of the silo. Company A fell behind schedule to complete the operation which led the cement plant to terminate the agreement. An assessment of the remaining work volume was done by the crew leader who considered it to be easy. To carry out this deburring, they used a suspended platform with an electric winch. The crew leader was present at the bottom of the silo to supervise and coordinate the work, two other workers (I1 and another) were with the leader underneath the walkway to guide the rotational movements of the walkway using two ropes. Another worker was above the silo in charge of the platform's electrical movements. The operator who was on the platform dislodged the hard cement using a jackhammer, when a collapse of the stuck material occurred. The accident occurred when a large section of cement stuck to the silo wall detached and buried the workers and crew leader who were at the bottom of the silo. The worker who was near the silo's manhole cover was ejected outside of the silo. The crew leader and worker I1 died, buried under the collapse. Organisation des faits.

Enforcing organizational provisions that prevent workers from being positioned at the bottom of the silo, eliminating the risk of being buried in the event of cement collapse.

- Conducting a risk assessment (on site) before the start of any intervention operation by a team trained in occupational health and safety.
- Periodic maintenance and cleaning of work equipment (silos)
- Training the staff of silo maintenance and cleaning companies in cement deburring and informing them of the risks.
- Automating the operation to eliminate the danger at the source.

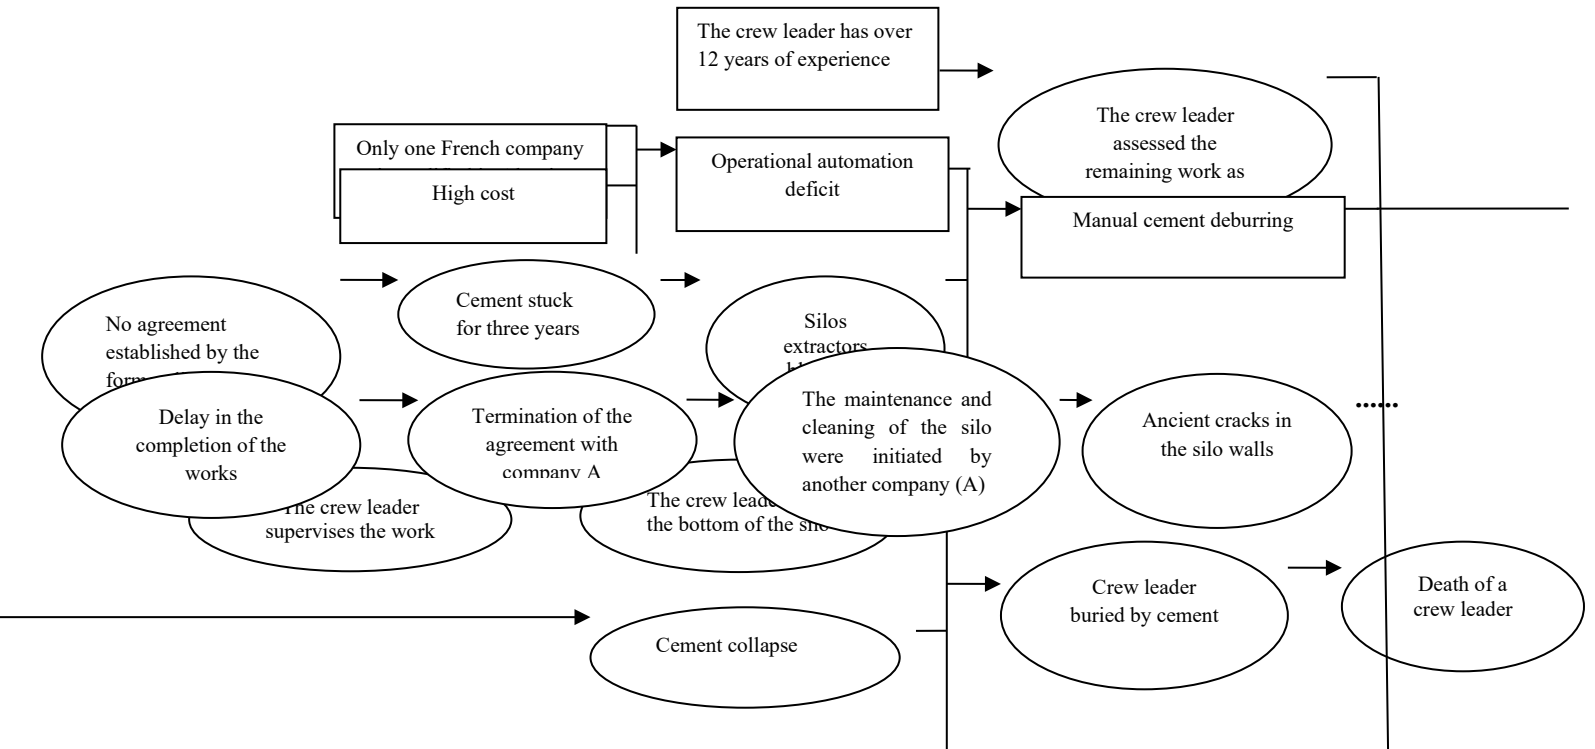
Cause of a deadly accident in a cement plant (death of the crew leader) presented in figure 2 and. The causal analysis of a fatal accident in a cement plant leading to the death of a worker presented in Figure 3

Figure 2. Cause-tree of a deadly accident in a cement plant (death of the crew leader)

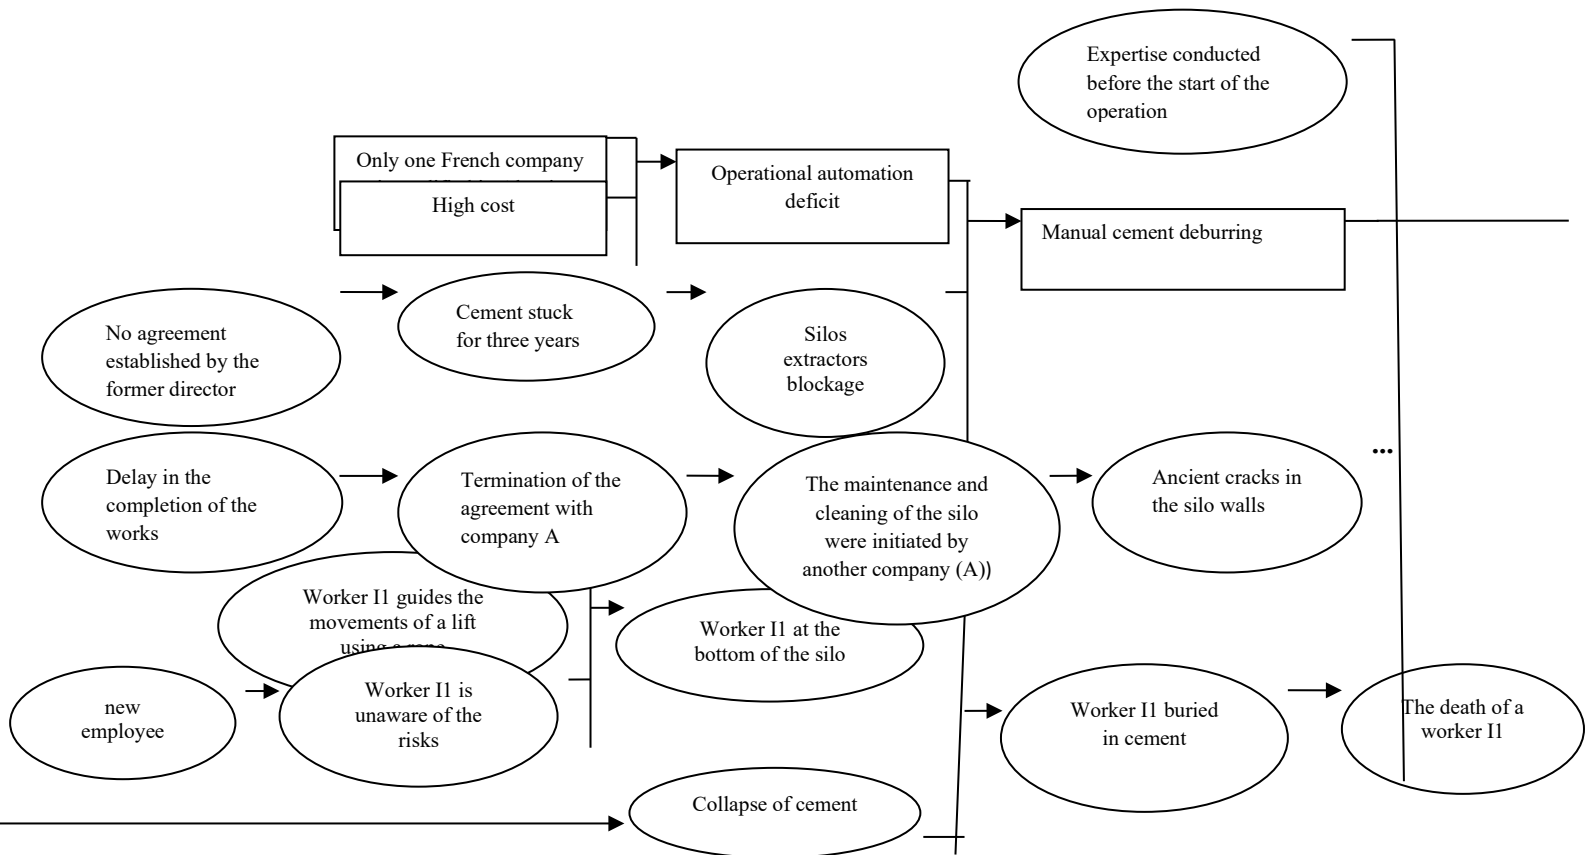
Figure 3. The causal analysis of a fatal accident in a cement plant leading to the death of a worker
