Investigation And Analysis of a Fatal Occupational Accident

N.Chenouf and W. Benhassine
Occupational Health Service
University Hospital Center Batna, Algeria

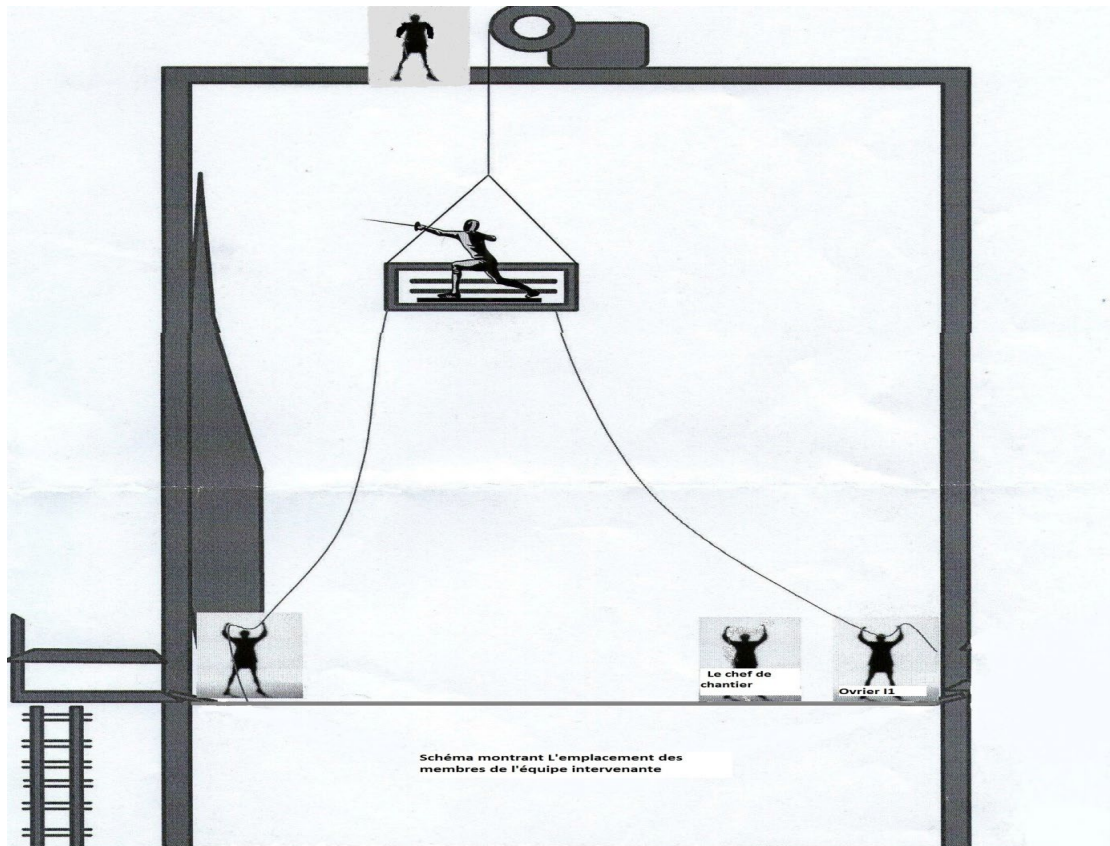
- Cement stuck to the walls for 03 years, the former director did not establish an agreement with a cement silo maintenance and cleaning company.
- Maintenance and cleaning of the silo was started by another company (Company A), which caused cracks to appear in the cement stuck to the walls of the silo.
- Company A fell behind schedule to complete the operation which led the cement plant to terminate the agreement.
- The remaining work was contracted to Company B.
- An assessment of the remaining work volume was done by the company supervisor and crew leader.
- The crew leader considered the remaining work easy to carry out. Figure 1 showing the location of the response team members at the silo (Figure 1 and Figure 2).

Figure 1. The location of the response team members at the silo

The accident occurred at 8:20 am where a crew consisting of a crew leader and four workers employed by a cement silo maintenance and cleaning company (Company B) started work at 6:00 am. Their activity consisted of dislodging the hard cement stuck to the walls of a silo which had caused the extractors to clog. This operation had been started by another deburring company (Company A), which caused cracks to appear in the cement stuck to the walls of the silo. Company A fell behind schedule to complete the operation which led the cement plant to terminate the agreement. An assessment of the remaining work volume was done by the crew leader who considered it to be easy. To carry out this deburring, they used a suspended platform with an electric winch. The crew leader was present at the bottom of the silo to supervise and coordinate the work, two other workers (I1 and another) were with the leader underneath the walkway to guide the rotational movements of the walkway using two ropes. Another worker was above the silo in charge of the platform's electrical movements. The operator who was on the platform dislodged the hard cement using a jackhammer, when a collapse of the stuck material occurred. The accident occurred when a large section of cement stuck to the silo wall detached and buried the workers and crew leader who were at the bottom of the silo. The worker who was near the silo's manhole cover was ejected outside of the silo. The crew leader and worker I1 died, buried under the collapse. Organisation des faits.

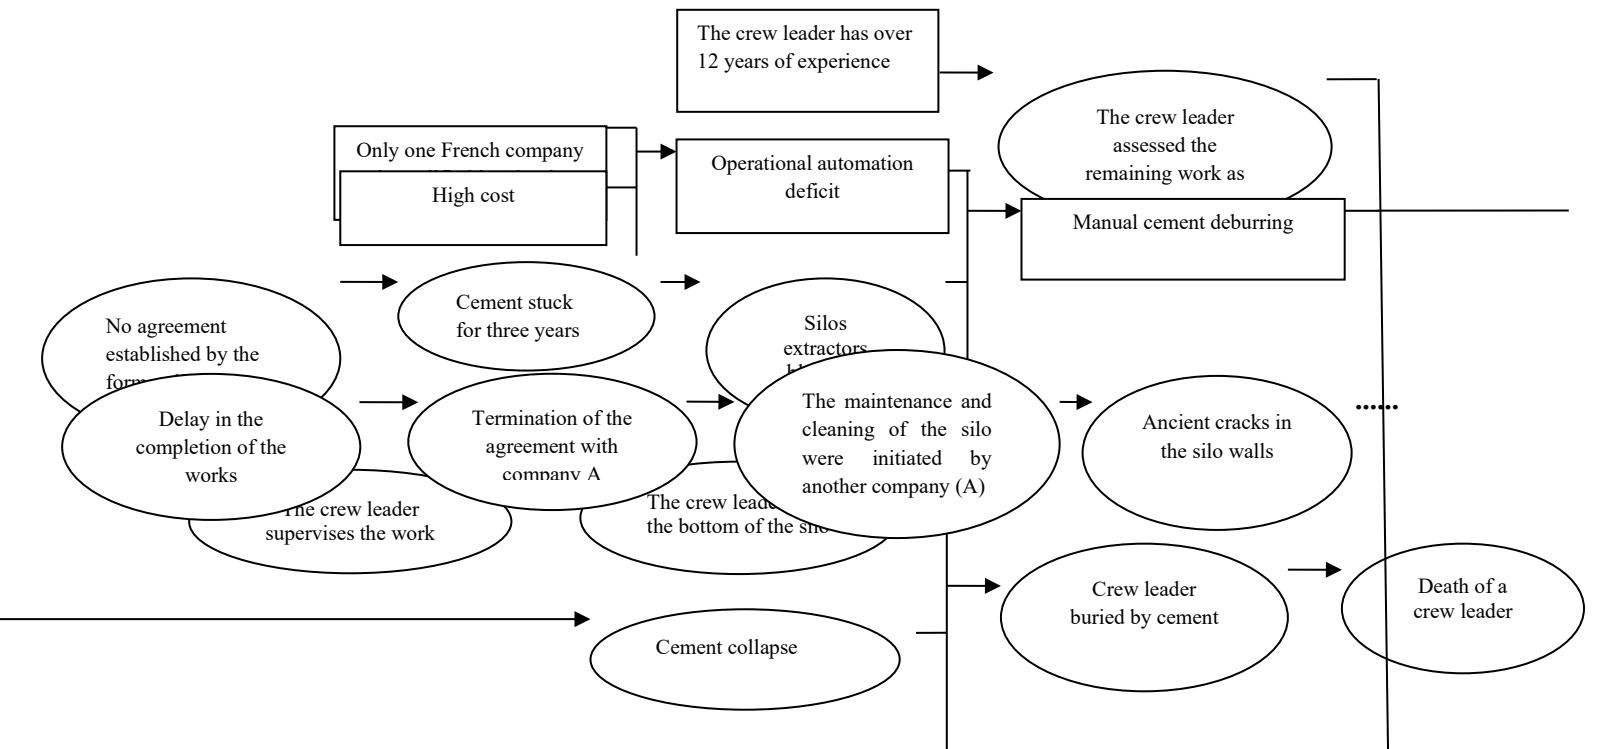
Cause of a deadly accident in a cement plant (death of the crew leader) presented in figure 2 and. The causal analysis of a fatal accident in a cement plant leading to the death of a worker presented in Figure 3

Figure 2. Cause-tree of a deadly accident in a cement plant (death of the crew leader)

Enforcing organizational provisions that prevent workers from being positioned at the bottom of the silo, eliminating the risk of being buried in the event of cement collapse.

- Conducting a risk assessment (on site) before the start of any intervention operation by a team trained in occupational health and safety.
- Periodic maintenance and cleaning of work equipment (silos)
- Training the staff of silo maintenance and cleaning companies in cement deburring and informing them of the risks.
- Automating the operation to eliminate the danger at the source.

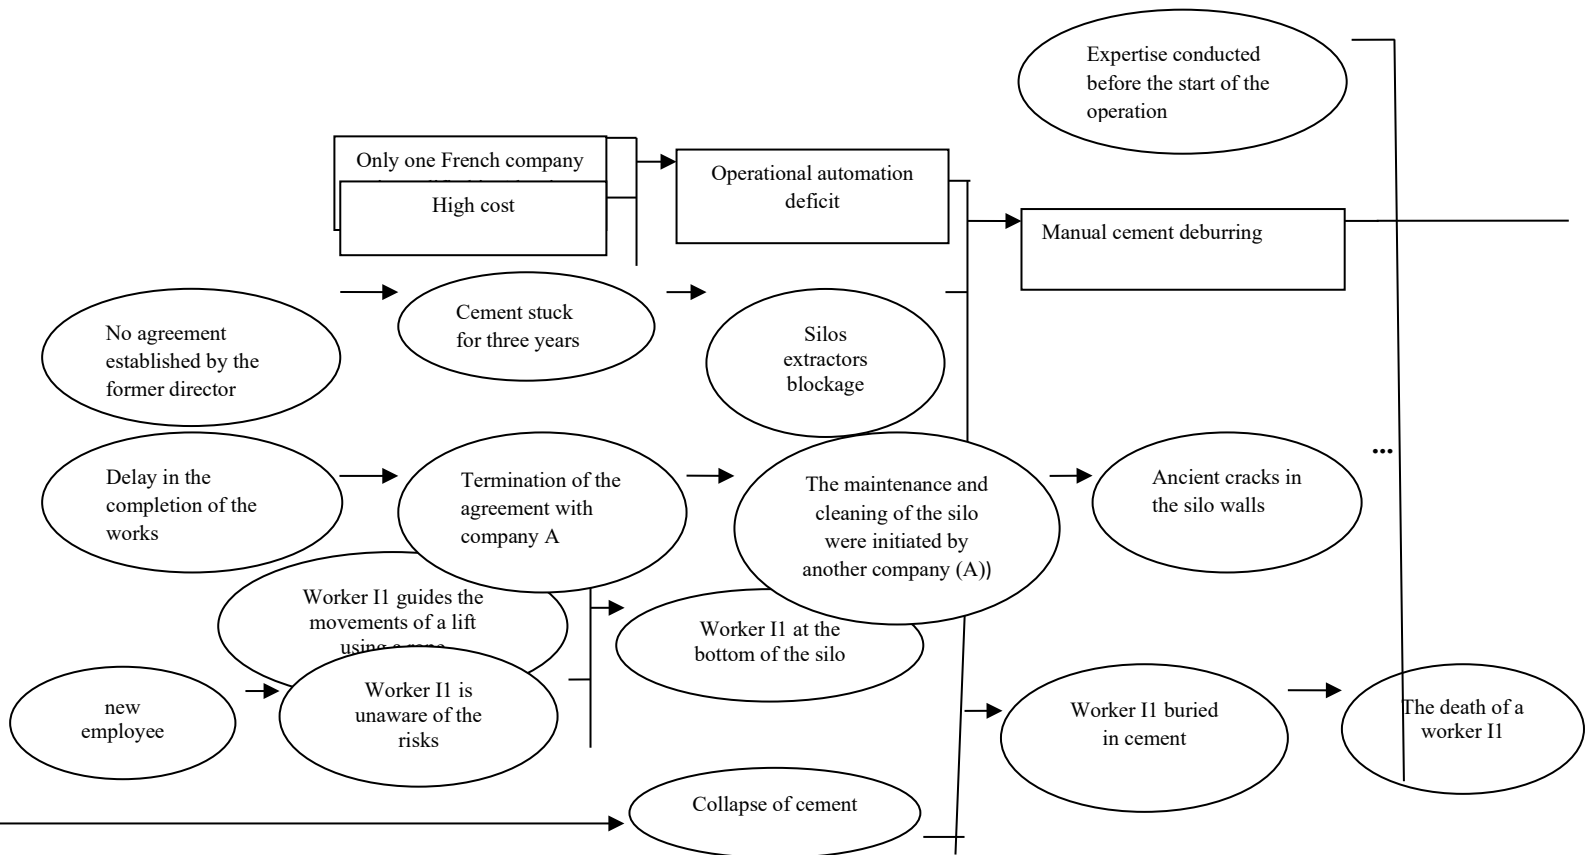
Figure 3. The causal analysis of a fatal accident in a cement plant leading to the death of a worker
