Investigation of the Mechanism Failures of High Temperature Components Occurring Inside Boiler Tubes

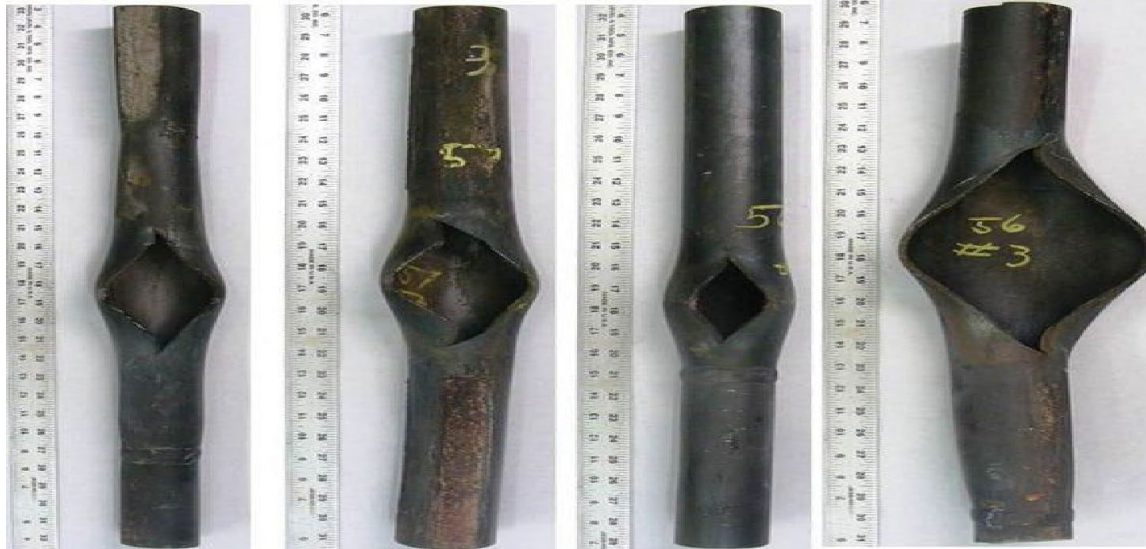
Thermal Mechanical Fatigue (TMF) is the results of cyclic thermal stresses and strains. These cyclic thermal stresses and strains are caused by temperature fluctuations. These cyclic thermal stresses and strains are caused by temperature fluctuations. This failure is leading mechanism or damage. The Figure 1 shows the example of the TMF.

Figure 1. Thermal Mechanical Fatigue [TMF]

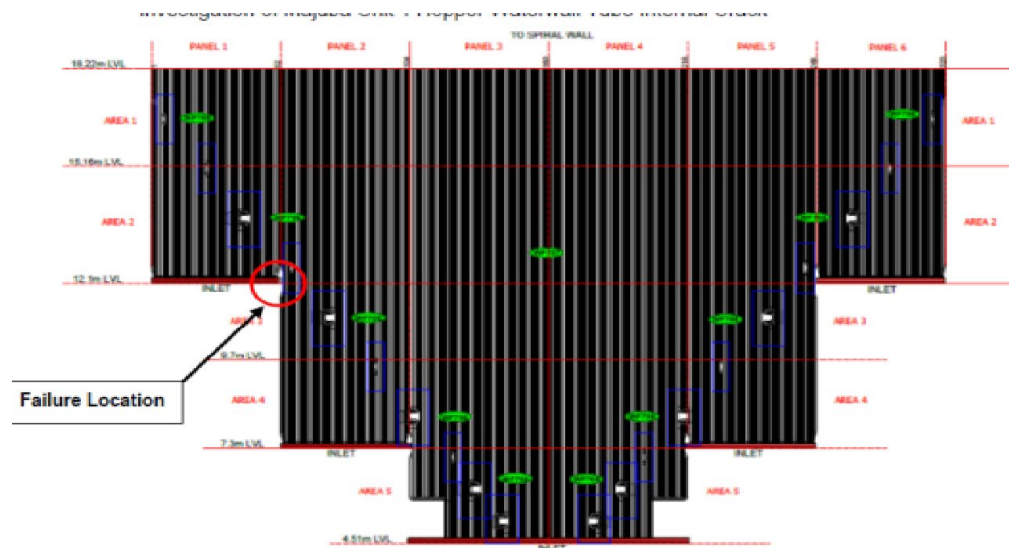
On the 13th of May, a tube leak was found on the Front Right Hand Side (RHS), Evaporator Helical Wall Tube E on the spiral to vertical transition at 63m level. The failure location is a known high-risk location for thermal mechanical fatigue related failures. It is noted that similar failures and areas were experienced in the past. The boiler had approximately 136 000 hours of operation at the time when the failure occurred. The hopper is dominant failure location for TMF but the exact location of this failure in this incident was different to the typical TMF location, refer to Figure 2.

Figure 2. TMF failed tubes location

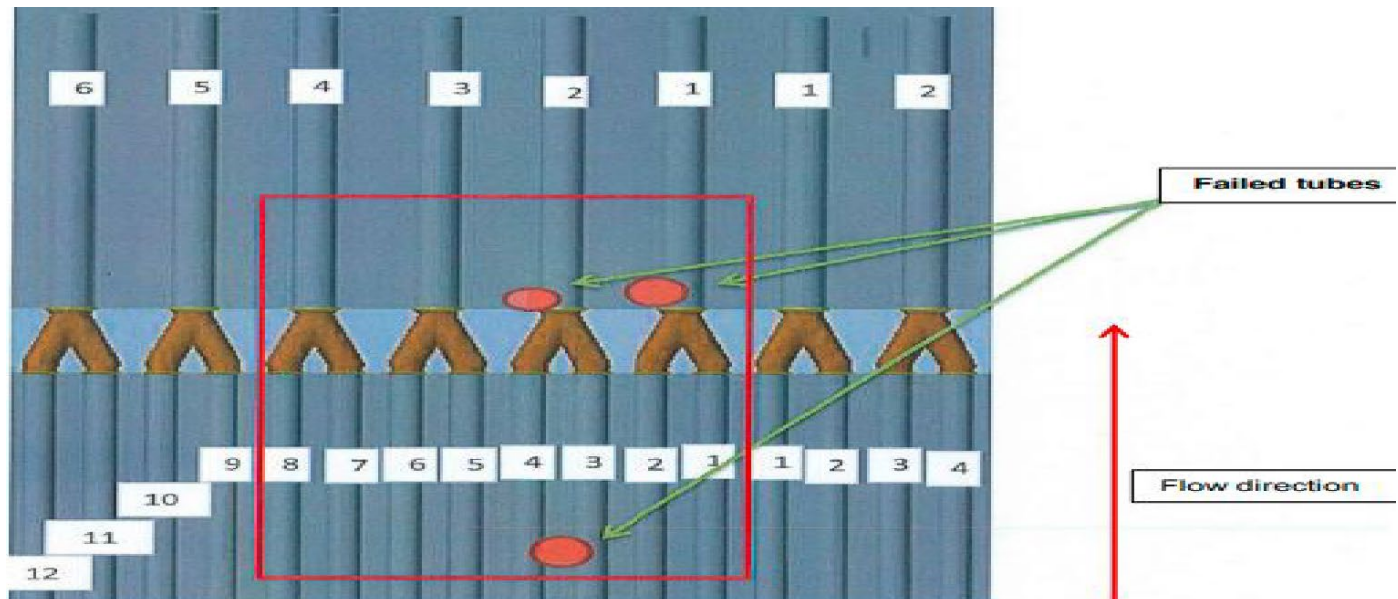
Unit 6 experienced a boiler tube failure on the 24th of May 2016. The failure was confirmed to be on SH1.1 tubes, SH2 Outlet tubes and RH2 Bundle Coil tubes. Failed SH1.1 and RH2 Bundle Coil tubes were cut out and brought to Eskom Research, Testing and Development (RT&D) for metallurgical investigation. However, SH2 Outlet tubes were not brought to RT&D for metallurgical evaluation. Failure on SH1.1 was confirmed on Tubes 3 and 4 (below the bifurcation) and Tubes 2 and 1 (above bifurcation) during site inspections (as shown in Figure 1). Tubes adjacent to the latter tubes were also removed due to the wall thinning likely from steam washing. RH2 Bundle Coil Tubes 3 and 4 were removed due to failure noted (during site inspection), while adjacent tubes (Tubes 1 and 2) were also removed due to severe wall thinning. Several SH2 Outlet tubes were reported to be removed due to severe wall thinning noted when inspections were carried out in this area (the latter tubes were not brought for investigation). The SH1.1 flue gas screen was found detached from the attaching plates (this was noted during site inspections conducted when the boiler was shut down), see Figure 3. The screen was also not brought for investigation.

Figure 3. TMF failed tubes location.

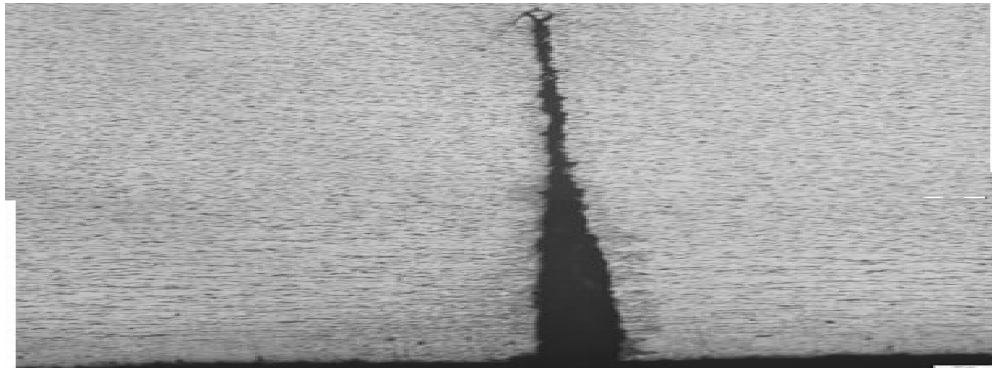
Figure 4. Optical Micrograph Showing Crack.

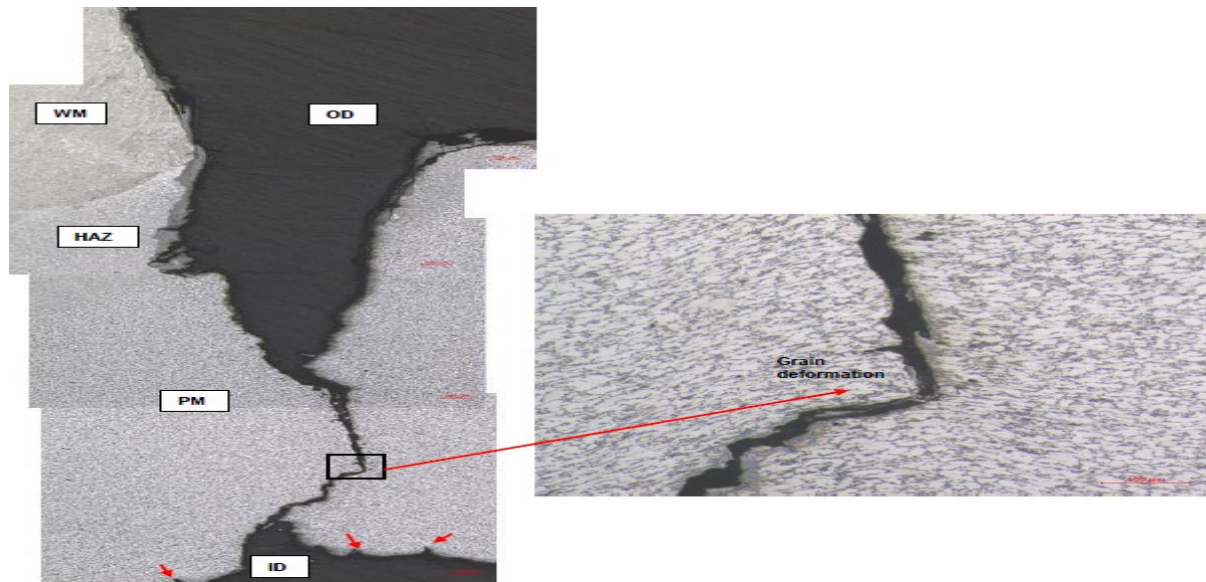
Figure 5. The thermal mechanical fatigue through wall crack that initiated from the outside diameter on the weld toe and propagated towards the inside diameter of the tube.
