Finite element analysis on acid compressor expansion turbine: Case for Fertiliser Company

This paper reviews the use of finite element analysis to determine the causes of the failure of the compression expansion turbine for the nitric acid plant that occurred at the company (August 2017). After an extensive literature study on the main causes of turbine failure, the researchers conducted a finite element analysis on the material of the turbine blades (Austenitic) and found out that the base metal used for the alloy may have failed to withstand the high temperatures (640°) that the turbine was subjected to. This research is going to help prevent future failure by use of material that can withstand high thermal stresses.

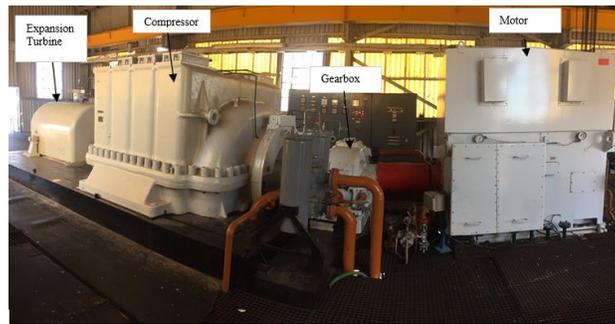
Figure 1: Layout of the turbo-machinery.

Nitric acid is one of the major requirements in the manufacture of nitrogen-based fertilisers. The hot waste gas from the production of nitric acid is disposed to the atmosphere through a gas turbine that recovers the energy. The other gases leaving the cooling section are then mixed with air and nitrogenous oxides from the acid solution and then compressed to a higher pressure for absorption (Ave. E van Nieuwenhuysse, 2000). Turbomachinery in the nitric acid plant consists of a motor, gear box, compressor and the expansion turbine as shown in the diagram below:

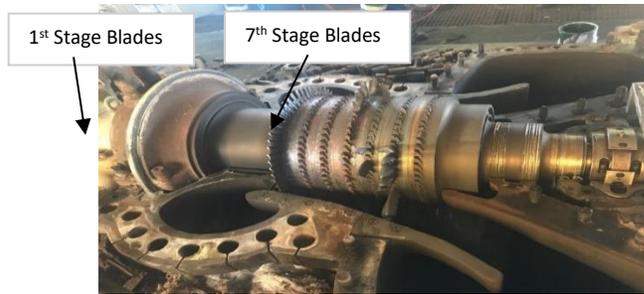
Figure 2: Damaged turbine rotor

On the 10th of August 2017, there was an extensive turbine failure in the nitric acid plant at the company nitric acid plant (North Acid compressor train). The turbine blades were ripped off from the rotor as shown in the diagram below:

The results of the finite element analysis showed the flow projections of the nitrous oxide gases in the turbine, the pressure distribution, shear and thermal stresses induced. The researcher concludes that the acid compression expansion turbine may have failed due to creep fatigue.

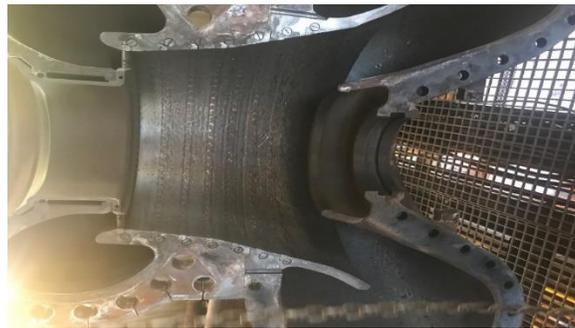
Figure 3: Damaged turbine stator

The stages of the stator that correspond to the blades in the rotor were also ripped off except for the first stage rows only as shown below:

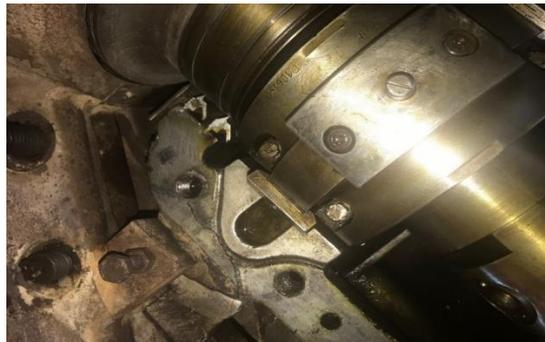
Figure 4: Damage to the turbine pedestal

The turbine pedestal that carries the bearings was also damaged on the non-drive as well as two of its supporting legs and while the drive end remained intact. The non-drive end of the pedestal is shown in the diagram below:

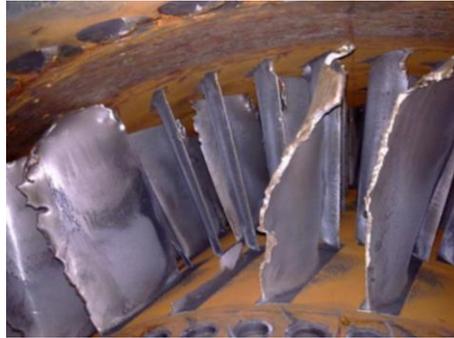
Figure 7: Corrosion failure in turbine blades

This type of failure usually occurs when the blade material is oxidized during the chemical reactions on its surface and this is catalyzed by high temperatures and acidic conditions which are dominant in the nitric acid plant.

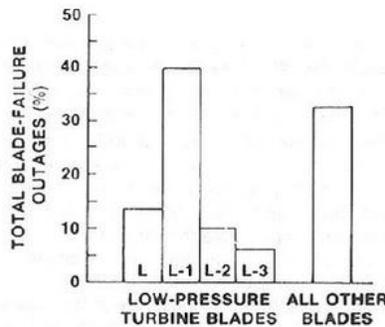
Figure 8: Distribution of failure in turbine blades

Low-pressure blades of a turbine were found to be more susceptible to failure compared to the intermediate and high-pressure blades. The most common failure mechanisms that occur in low-pressure blades are corrosion fatigue, stress corrosion cracking, Pitting and Erosion-Corrosion in the turbines. Corrosion due to fatigue is the most abundant mode of failure in the turbines (Sulfidation: Turbine Blade Corrosion, 2008).

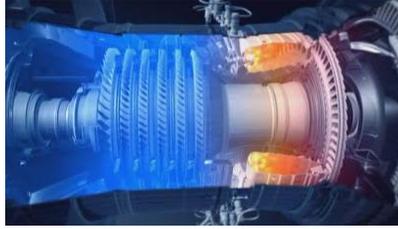
Figure 9: Fretting fatigue failure in turbine blades

The cracks in fretting fatigue start out small but with time spread all over the blade and lead to severe damage. Fretting fatigue can be prevented by reducing slip in the initial stages of the design process (Anon., 2002).

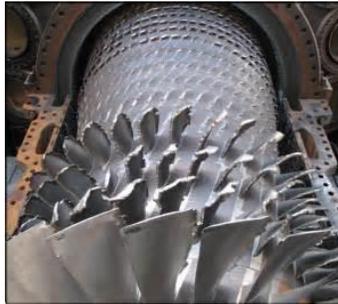
Figure 10: Creep fatigue failure in turbine blades

The turbine operates under very high temperatures and is subjected to high stress levels. This is caused by the high frequency of the cycles during loading in the high pressure stages of the turbine. This high fatigue cycle contributes to most of the failures that occur in the turbine (Alves, 2016).

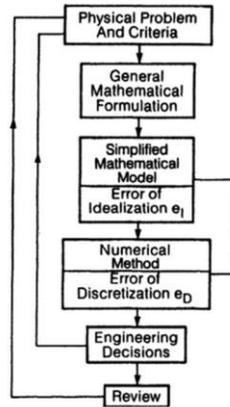
Figure 11: Finite element analysis procedure

Clean Up of the 3D CAD Model: The basic procedure for finite element analysis is shown below.

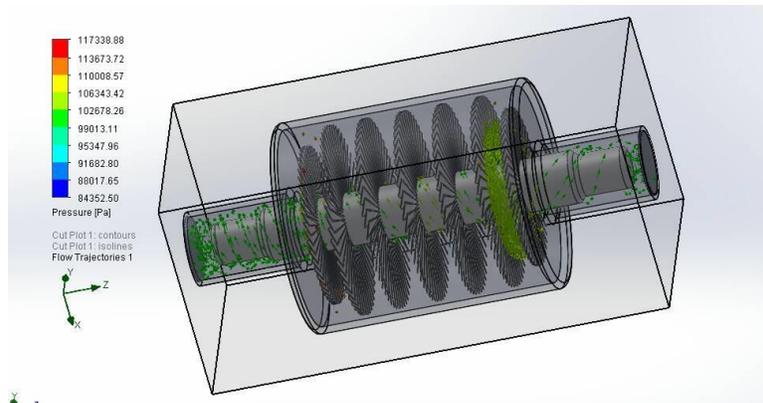
Figure 12: Solidworks drawing for the blades

The flow trajectory shows how the nitrous oxide gas flows from the inlet to the outlet. The flow gets more turbulent towards the outlet. Atmospheric pressure conditions were used as the end conditions.

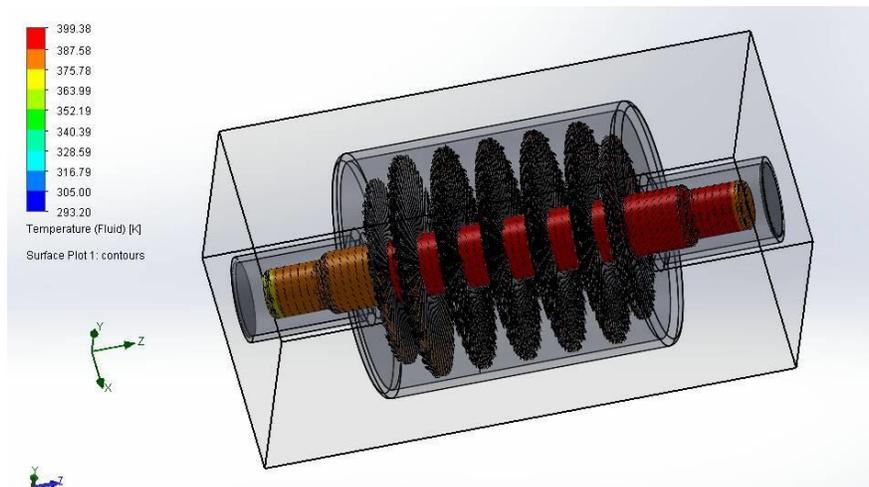
Figure 14: Temperature distribution

The inlet temperature was 640 and the outlet temperature was 250°. The blade material was specifically designed to withstand the high temperatures.

Since the turbine blades were exposed to high temperature as seen in the simulation there is need for material redesign to find a material more suitable for higher temperatures.

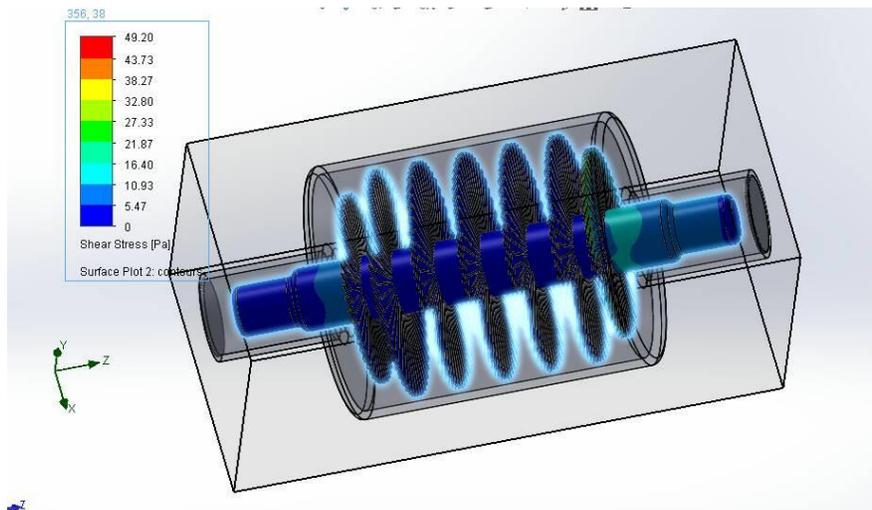
Figure 15: Shear stresses

The turbine blades are able to withstand the shear stress during rotation.
