Improvement on Geotechnical Failures at Erap Bridge Embankments

Abstract

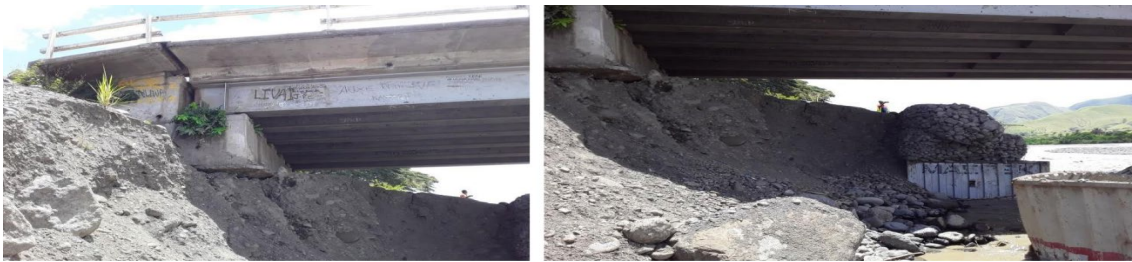
Figure 4. Hanging abutment without support (left), crumbled embankment from steady erosion (right)

When water infiltrates through the allowable porosity, walls eroded microscopically at a constant rate every second. This happens for almost all year round. As such, the river banks crumbled and held loose, thus dissolved into the water, creating an underwater cave and hollow where the dam is vulnerable to crumble. Weight of existing huge lumps, including substructure or superstructure pressured on the barrier, where it no longer sustains its pressing stress. Thus, the result was tedious and server as observed on site. The exposed and vulnerable or weak abutment exposed without rigid support from the dam has seen to have been weak. Terrible consequences expected ahead when timely rectification processes not provided, as shown in Figure 5 possible corrective measures need to take, as demonstrated in Figure 4 and 5.

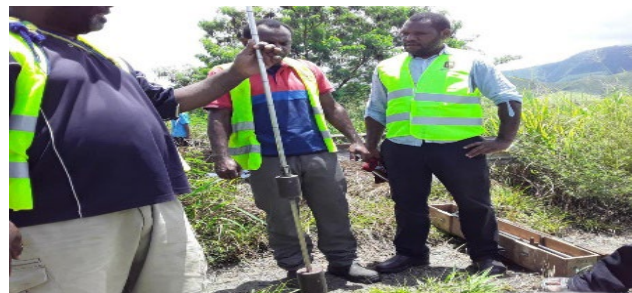
Figure 7. Dynamic cone penetration test (DCPT) on Erap Bridge site

The dynamic cone penetration test is the fastest and cost-effective method to determine the strength of compacted pavements/embankments of any structure's nature. The analysis customarily performed to compare and evaluate laboratory tests' conclusion to understand the nature of soil constituents and strength properties ('Bridge Procedures and Design Guide', 2018). Initial reading has recorded on the dynamic cone penetrometer scale. Compute the value of the penetration (in mm) for every blow by previous text recorded from the current. Compute the cumulative depth of penetration for every bump through the addition of last each depth of penetration as pictured in Figure 7-9, and associated graphs plotted as shown in Table 1 and Table 2.

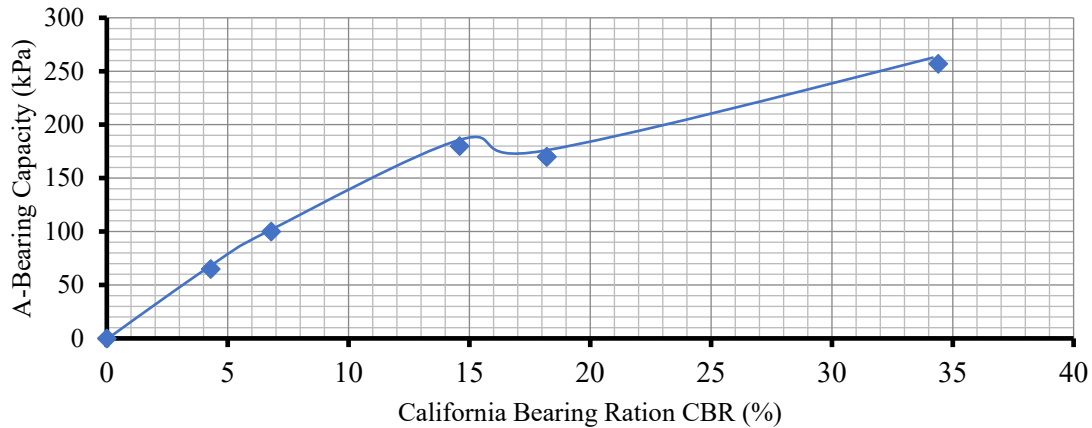
Figure 9. CBR (%) versus allowable bearing capacity (kPa) from field test

Thus, the site's possible result derived and evaluated suggests that both sides of the dams have adequate compaction but penetrated through allowable bearing capacity, which means no clay particles for sufficient cohesiveness and binding or consolidation. The CBR values again fall between 6.8% to 34.4% on Lae side while 6.8% to 18.2% on Goroka side, which means less strength attained and less consolidated as depicted in Figure 5. This further resembles that materials were weak and porous with the nil existence of clay for active binding and cohesiveness. This is correlated and concluded in the same approach as with the lab test.

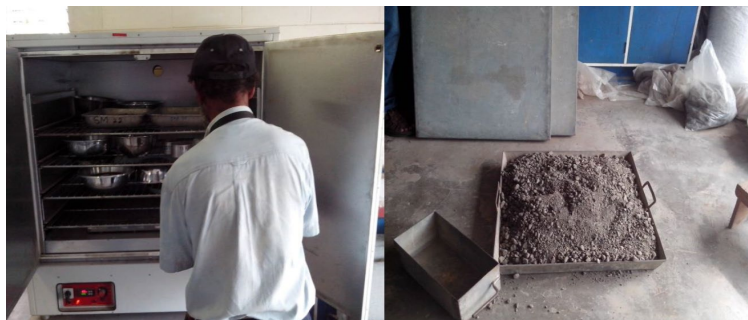
Figure 10. Oven dry samples (left), air dry samples (right)

The particle size distribution test customarily conducted to determine a particular site's material properties. It further determines and resembles the size of soil present in a specific location. PSD tests conducted through a range of procedures and maximum allowable time required effectively completed to attain the expected quality results. In Lae, the preparation and the steps for the particle size distribution (PSD) test analysis in depth of Erap bridge embankments as follow: The samples collected were air-dried on an open rectangular steel tray for four days on either path; two separate plastics were also collected on both sides for moisture content through oven-dried; samples then sieved through different sizes of sieve bowls from 75 mm to 32 micro millimeters; sieved particles up to 9.5 mm even distributed through 250 grams each for both sides and oven-dried for effective dewatering from a soil sample. Results are then calculated and noted in lab sheets for further testing to calculate moisture content (Figure 10).

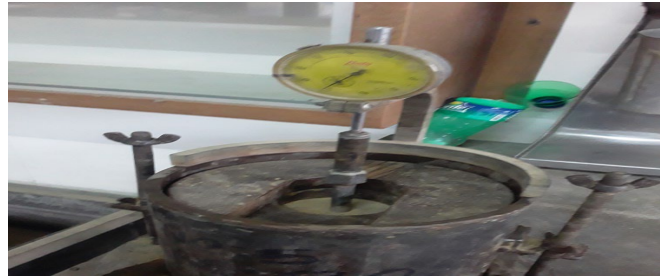
Figure 11. Before shocking (Gauge reading)

There were two distinct tests conducted on the preparation for geotechnical improvement on Erap bridge embankments. One has done on-site while next effectively performed in the civil engineering laboratory. The current work focus, which is to improve geotechnical failure on Erap Bridge and recommend possible conclusion, all tests were allowed equal focus and attention. Procedures undergone includes but not limited to; The two specimens, each of approximately 7.5 kg, have been compacted generally with 53 blows in a mold. Initially, the weight of an empty shell is taken from the balance in grams (g) and recorded. Water has been added to the first sample and compacts it in 3 layers by giving 53 blows per layer. The collar is removed after compaction and leveled the layer. The moisture content determined by taking samples. Weight of mold noted plus compacted specimen. The pattern plus specimen is placed in the soaking tank for four days as seen in Figure 10 as ready to be submerged into the tank after gauge reading (Figure 11).

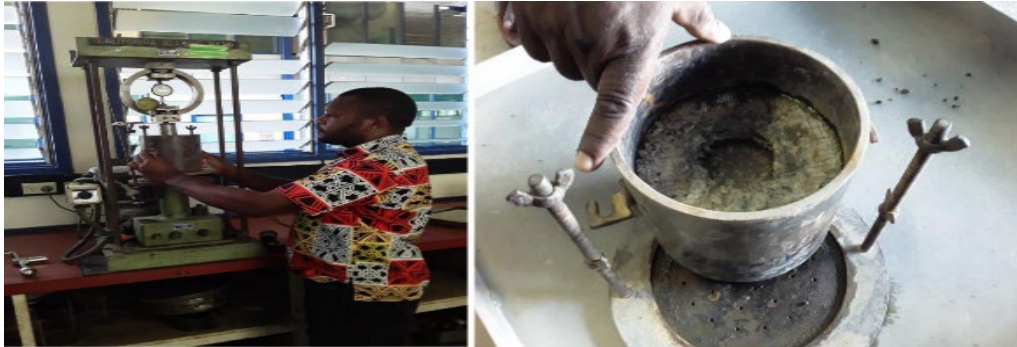
Figure 12. Ready for CBR penetration test (left), after penetration (33 mm depth)

The next approach samples conduct by repeating the same technique. Before socking in the tank, the swell reading noted. After four days, again, take the swell text and find the shrinkage difference in percentage. Next, allow water to dehydrate from mold, thereby removing from the tank. The specimen was removed after four days of socking, placed under the CBR penetration machine, and applied the load from 1Newton every interval of between 0.5 mm, 1mm, 2 mm, 3 mm, etc.

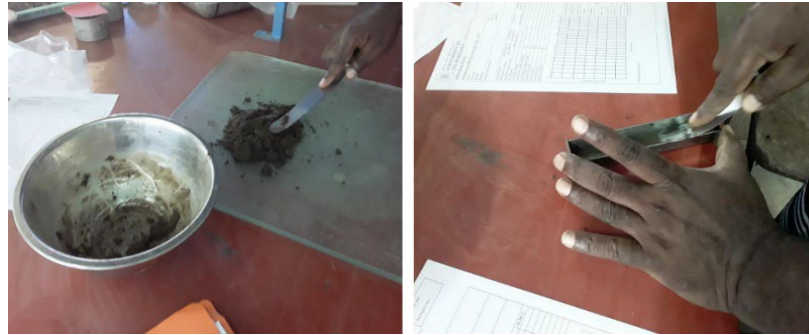
Figure 13. Tilting samples (left), packing in steel bowl (right)

The mass of particles retained from 32 micro millimeter dish mixed with water. Then, the mixture tilted several times and packed into a shrinkage rectangular-shaped steel bowl. Shrinkage determines that further water loss will not reduce the volume of soil packed due to adequate water content. Collect results and noted, which shows much reduction in shape or size, thus considered non-plastic, as shown in Figure 13-14.

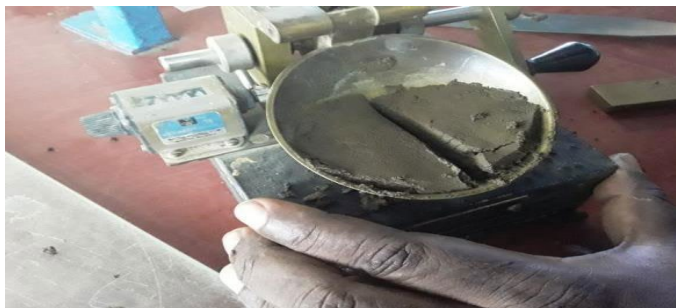
Figure 14. Depicts casagrande cup full of soil for liquid limit test

On Lae side dam, we have done a practical test to re-evaluate the plasticity of the samples. Thus, the full procedural test of atterberg has conducted to analyze all levels of analyses. The results were again as unsatisfactory and failing due to limited binders. The samples also concluded as non-plastic material; thus, the maximum porosity has been analyzed this time through the test (Bureau, 1999). The procedures executed in the following manner but this time for the liquid limit test; The same procedures as in the first instance, the Casagrande cup was packed with moisture soil samples to half its spherical. Cut through the center by “V” shaped groove using as in standard procedure. Then the cup dropped from the height of 10 mm at a rate of 2 drops per second. The separated half of the soil on the cup meets each other in less than ten counts. The ground was considered less binder and crumbling, thus meets its end in less count, as shown in Figure 14.

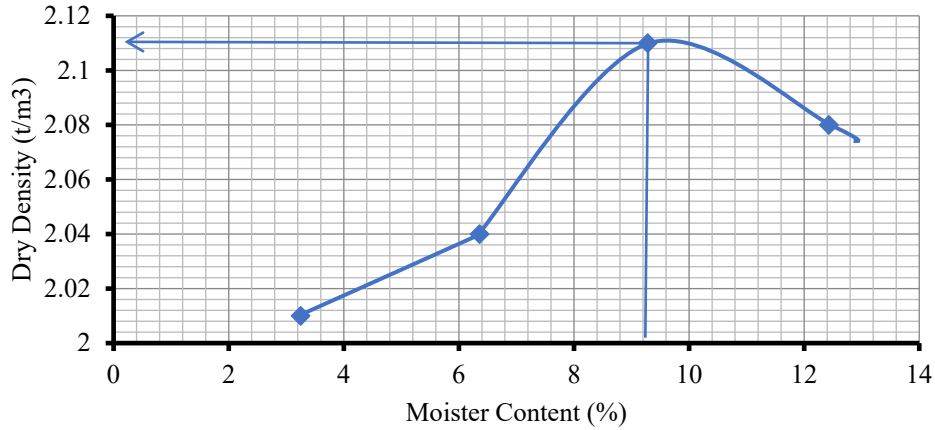
Figure 15. Moisture content against dry density from lab test as presented in Table 3

At 9.28 % moisture, the dry density at maximum is 2.11 t/m³. The material is non-plastic or nil clay particles for cohesiveness and paltry binder constituent. As such, the filled materials turned to be losing or maximum porosity and crumbling when a flood hits embankment wall. Require an effective combination of selective equipment to reflect better-consolidated embankment (Institute, 2013).
