Identification of Service-Oriented Degradations using Non-Destructive Testing Methods on Passive Direct Methanol Fuel Cell Components

N. V. Raghavaiah and G. Naga Srinivasulu

Research Scholar, Department of Mechanical Engineering
National Institute of Technology (NIT), Warangal, India

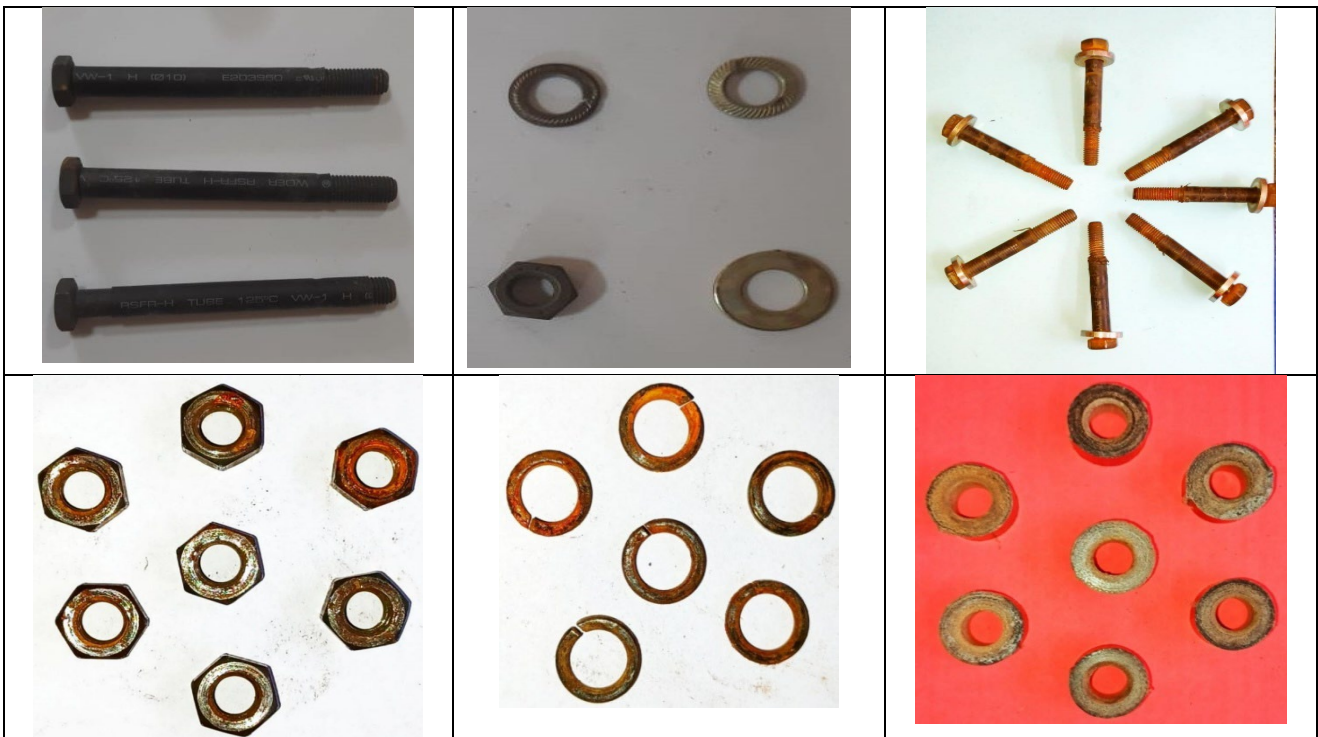
Figure 9. (a) As received MS Bolts with an insulating cover, (b) As received washers and nuts, (c) Corroded bolts after a service period of 2 years (d) Corroded nuts after a service period of 2 years, (e) Corroded spring washers after a service period of 2 years, (f) Corroded plain washers after a service period of 2 years

Within the PDMFC, it is observed that the fasteners such as bolts, washers, and nuts are getting corroded. The visual examination shows that the mild steel components react quickly and form surface oxides. Images of the bolts, nuts, and washers before the start of the experiment are shown in Figures 9(a) and 9(b), and after a service period of 2 years are shown in figures 9(c), 9(d), 9(e) and 9(f). The corrosion rate of each fastener is calculated by taking the weights before and after the experiment. An average of seven sets of fasteners are calculated and tabulated and provided in Table 3.

Evaluation of test results: From the above interpretations, it is observed that there is a deterioration of fasteners. The root cause of the deterioration in the corrosive environment over the cell.

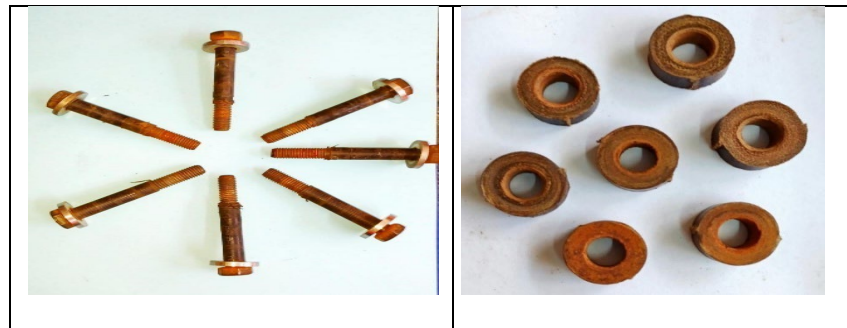
Figure 10. (a) Electrical insulating tube over MS Bolts after 2 years of service, (b) Bulged insulating sleeves after a service period of 2 years.

From the PDMFC, it is observed that the wrapped tubes and sleeves over bolts are getting bulged. From the visual examination, it is observed that the tubes are getting peeled off due to frequent assembling and dismantling. However, the sleeves are getting bulged under compressive loads of bolts and nuts. Images of the insulating tubes and sleeves after a service period of 2 years are shown in Figures 10(a) and 10(b).

Evaluation of test results: From the above interpretations, it is observed that there is damage to tubes and sleeves. The root cause of the deterioration is the compressive loading on sleeves and the rubbing of tubes during assembling and dismantling. Physically damaged insulating sleeves and tubes need to be replaced for equipment and personal protection.
