*14th Annual International Conference on Industrial Engineering and Operations Management
Dubai, United Arab Emirates (UAE), February 12-14, 2024*

Analysis of Bolt Failure Locations for Predictive Maintenance

In this work, a population of fractured joint bolts have been collected from automotive and tire plants, and an analysis of each bolt is performed to determine the cause of failure, and crack initiation site location on the bolt. The bolts are then grouped by failure cause and location to investigate the probability of failures and probability of failure location. The results show that low-cycle and high-cycle fatigue account for 70% of bolt failures, and that 80% of bolt failures occur deep in the threaded region in the bolt. Failure locations that were closer to the intersection of the head and the shank were only found in samples that were determined to have failed due to low-cycle fatigue. Still then, only 40% of bolt failures that result from low cycle fatigue take place closer to the head, and 60% of the failures occur in the threaded region away from the head. The results of this study can help predict the failure location on the bolt, and thus help guide preventive m

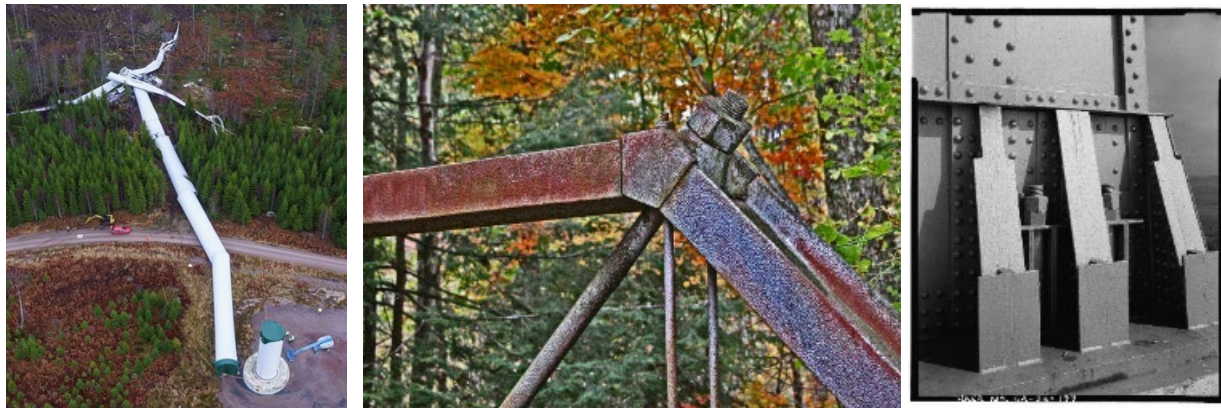
Figure 1. A wind turbine structure that collapsed due to a bolt failure (Swedish Accident Investigation Authority, 2017), picture is obtained with permission from Vestas Wind Systems A/S, Sweden (Left). Bolted bridge structure in Ohio (Center). Bolts at the base of the pier W-6 tower of the San Francisco Bay Bridge (Right). (Center and Right pictures are in the public domain, source: Wikimedia Commons).

Investigation Authority, 2017) (Figure 1), and the collapse of the roof of the Kemper Arena in Kansas City in 1979 which is attributed to fatigue stresses in bolts (Levy & Salvadori, 2002).

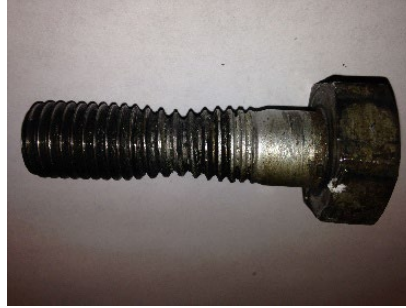
Figure 2. A bolt that failed from pure tensile overloads. The bolt underwent thinning and axial elongation, and was retrieved by the technicians before it fractured.

- c. Bolt failure due to fracture from tensile stresses:** This failure is caused by creep and overloads that result in stresses that exceed the ultimate strength of the material. This failure typically occurs at the bolt if the proper number of threads are engaged (Brown, Morrow, Durbin, & Baca, 2008) (Oberg, Jones, Holbrook, & Ryffel, 2008), otherwise, thread stripping takes place before bolt fracture, a scenario that should be avoided. Sandia National Labs Guideline for bolted joints (Brown, Morrow, Durbin, & Baca, 2008) recommends the use of bolts with threads of a lower tensile strength than that of the threads of the bolted material. Furthermore, bolt fracture from axial overloads should occur in the body or the threads rather than at the intersection of the head and the shank (Robinson, 2006). A sample of a bolt that failed from pure tensile overloads is shown in Figure 2. Here the bolt underwent thinning in its middle section.

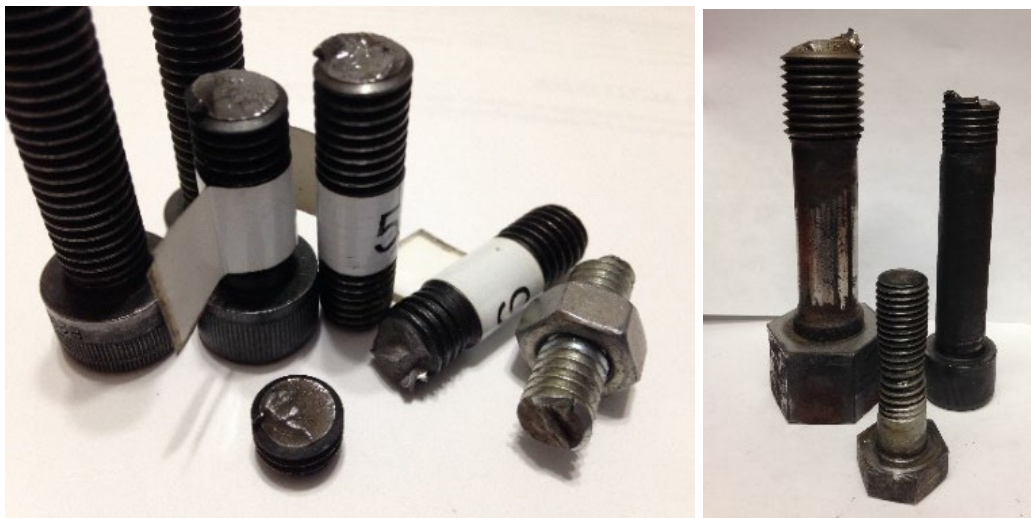
Figure 3. Failed bolts that have been collected for the study

Afterwards, five bolt failure modes are investigated by microstructural characterization using optical microscopy, a Keyence BZ-X800 Fluorescence Microscope was used for the analysis. Other methods may be used such as thermal analysis (Mohammadizadeh, et al., 2020) or using transmission electron and scanning electron microscope imaging (Molaei, Alizadeh, Attarian, & Jaferian, 2015) (Tantawi, Waddell, & Williams, Structural and composition analysis of Apex™ and Foturan™ photodefinable glasses, 2013) (Tantawi, Oates, Kamali-Sarvestani, Bergquist, & Williams, 2010), or Atomic Force Microscopy, which has the ability to capture both nanomorphology and mechanical stresses (Tantawi, Berdiev, Cerro, & Williams, 2013). However optical imaging provides the fastest approach while capturing real images of the structure (Figure 3).

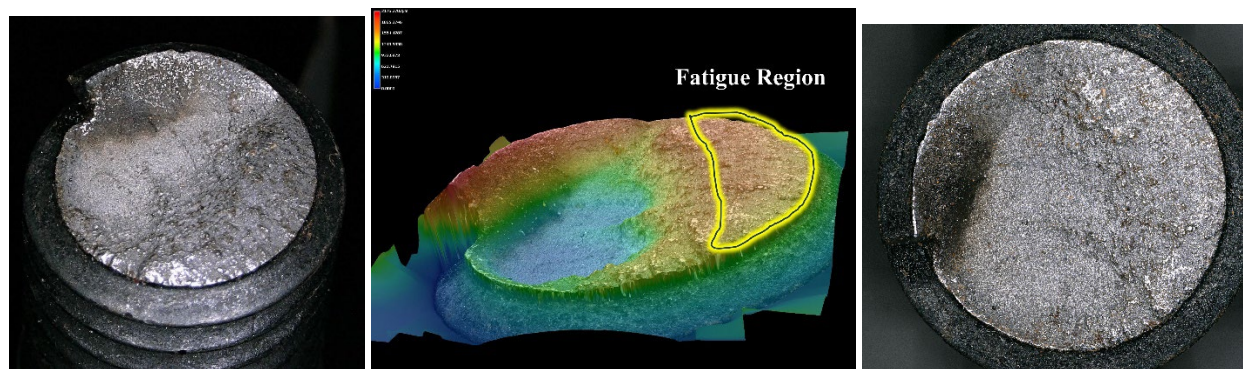
socket head cap screws failed in a stamping press machine in an automotive plant (Figure 5). The screws were manufactured in the United States, and made of alloy steel with a black oxide finish and a grade class of 12.9. Each of the failed screws was subjected to tensile and shear stresses during the cyclic operation of the steel pressing machine. Figure 4 shows the fracture at one of the screws. It can be seen that the screw failure location is at the vicinity of the stress concentration at intersection of the head and shank, a common site for fatigue crack initiation.

Investigation of the cross section of the fractured screw suggests that the cause of failure is initiated by a single fatigue crack propagation, followed by a tensile overload that caused rupture. The area of the overload rupture region formed approximately 75% of the cross-sectional area (characterized by the rough surface). This indicates that the bolt was subjected to high stress low-cycle fatigue. Consequently, from this analysis, the screw was most possibly subjected to heavy shock loads, that caused a fatigue crack to initiate at the root of the second thread from the head, the high tensile shock stresses caused the bolt to fail shortly after a fatigue crack was initiated.

Figure 4. A view of a failed screw at the failure location (Left), a topograph image that shows the depths of the fractured surface and the fatigue and overload failure regions (Center), and the cross section of the failed surface (Right).

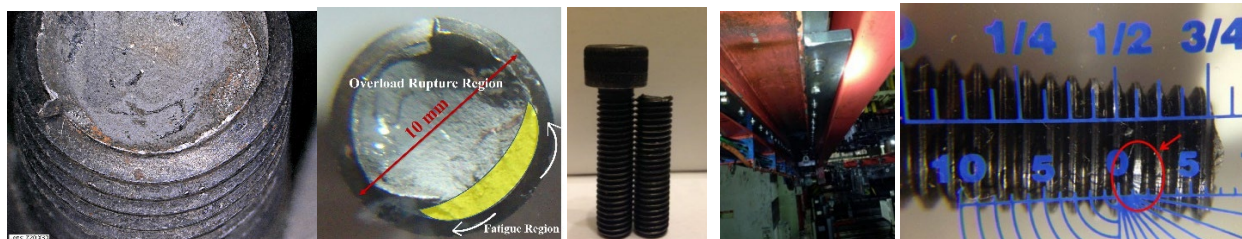
All the screws that came from the same stamping press machine exhibited similar failures with single crack initiation sites that usually occurred at the root diameter but at different locations along the shank. Another sample failure that was very similar to the one shown previously is shown in figure. Some bolts from the machine also suffered from minor thread stripping on the first four threads on the threaded part of the failed screw, another indication of the high tensile stresses in the axial direction. It should also be mentioned that the stripping might also have occurred when the operating technician tried to pull the ruptured screws out from its location.

Figure 5. A failed screw sample that exhibited similar fail pattern to that in Figure 4. The sample is shown next to a new socket head cap screw (Center). The stamping press from which the fractured bolt was taken (Center-Right), thread stripping on the sample (Right) (Tantawi, Ali, & Tantawi, 2015).

From Figure 5, it can be noticed that a fatigue crack initiated at the second thread root from the head of the screw in one location on the root diameter that could have resulted from a bending stress. The crack then propagated in both directions along the circumference of the screw. When the fatigue crack formed a crescent-shape that was 1.7 mm wide at the center, the increase in the tensile stresses due to the reduced operating area caused bolt rupture due to overload. The area of the overload rupture region formed approximately 85% of the cross-sectional area (characterized by the rough surface). This indicates that the bolt was subjected to high stress low-cycle fatigue. Consequently, from

this analysis, the screw was most possibly subjected to heavy shock loads, that caused a fatigue crack to initiate at the root of the second thread from the head, the high tensile shock stresses caused the bolt to fail shortly after a fatigue crack was initiated.

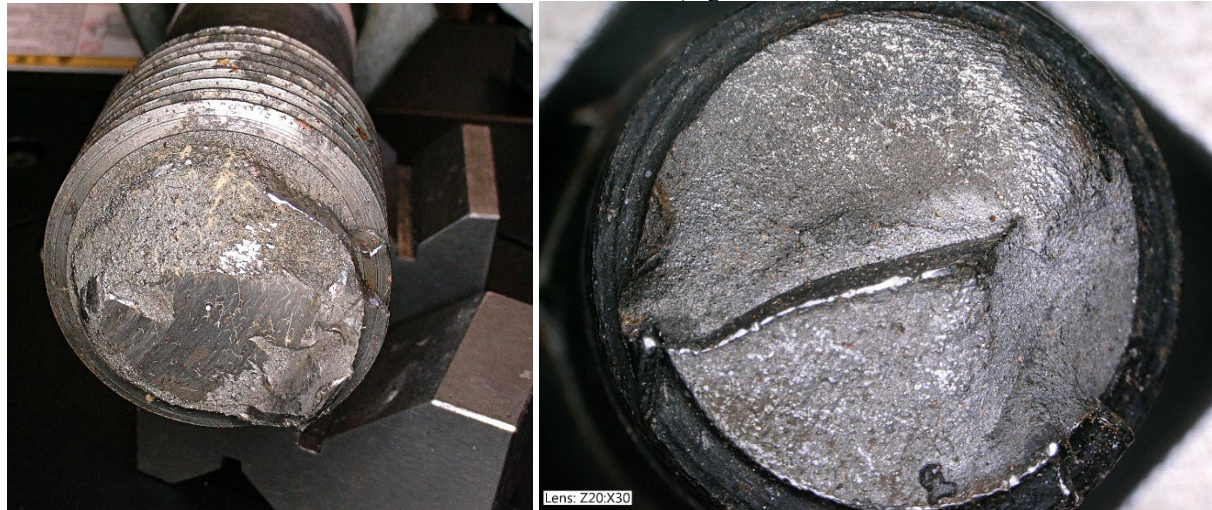
Preliminary investigation was conducted on eight other bolts; in total, seven bolts out of the population showed signs of a fatigue failure. Figure 5 shows a bolt that failed from a high-cycle fatigue (Figure 6- Right), and what appears to be a failure from a combination of a shear and tensile overload (Figure 6- Left).

Figure 6. Failure due to a combination of shear and tensile overloads (Left), and due to high-cycle fatigue (Right).
