Arch Bridge Construction Methodology: Lesson Learned from Failure Study

Arch Bridge Construction, Construction Sequencing, Temporary Works, Bridge Engineering, Case Studies.

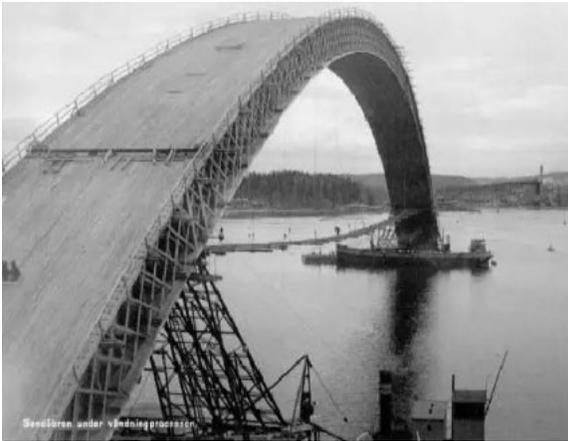
The Sandö Bridge was one of the earliest and most ambitious concrete arch bridges of its time. During construction, the timber falsework used to support the 264 m arch span collapsed under the weight of freshly poured concrete. Investigations revealed that the falsework lacked sufficient lateral bracing, and the stiffness of nailed plank connections had been overestimated (Åesson, 2014). The accident occurred on August 31, 1939, claiming the lives of 18 workers. Although overshadowed by the outbreak of World War II the next day, the disaster prompted a critical reevaluation of temporary works design in the field of bridge engineering. The bridge was later rebuilt with a more robust scaffold system supporting the arch throughout its entire length.

Figure 1. Different arch bridge failure cases (a) Sandö Bridge, Sweden; (b) Qijiang Rainbow Bridge, China; (c) Dos Valires Bridge, Andorra; (d) Chirajara Bridge, Colombia; (e) Nanfang'ao Bridge, Taiwan; (f) Tangail Arch Bridge, Bangladesh

One of the most critical lessons is that falsework and scaffolding must be engineered with the same rigor as the permanent structure. Both the Sandö and Dos Valires bridge collapses demonstrate that inadequately braced or poorly designed temporary supports can trigger catastrophic failure during concrete casting. Temporary structures should undergo full structural analysis, including three-dimensional stability checks, and be designed with redundancy in mind (*AASHTO LRFD Bridge Design Specifications*, 2007). Neglecting these elements can compromise even the most carefully planned construction operations.

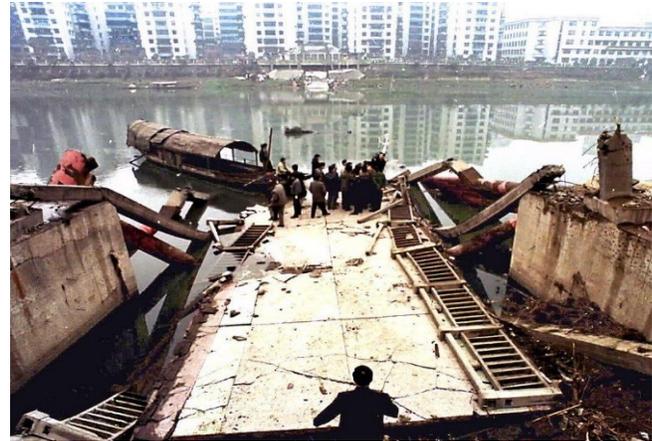
(b)

The Qijiang Rainbow Bridge, a 140-meter reinforced concrete arch bridge in Chongqing, collapsed just three years after opening. The failure occurred in 1999 and killed 40 people. The investigation cited severe deficiencies in construction quality, including the use of substandard materials, poor workmanship, and lack of proper maintenance (He & Chen, 2014). The incident gained national attention and resulted in criminal prosecutions of engineers and public officials involved in the project (Ding, 2001). It highlighted how construction shortcuts such as improper curing, weak reinforcement anchorage, and lack of quality control can compromise even seemingly sound designs (Wu et al., 2018).

The case of Qijiang Rainbow Bridge further emphasizes that construction quality control is critical from the foundation stage onward. Substandard materials, poor reinforcement placement, and lack of curing all contributed to its early failure. Quality assurance protocols must be strictly enforced at every stage from material selection and rebar installation to concrete testing and curing. Supervision must be continuous, and all site activities must align with the approved structural drawings and specifications.

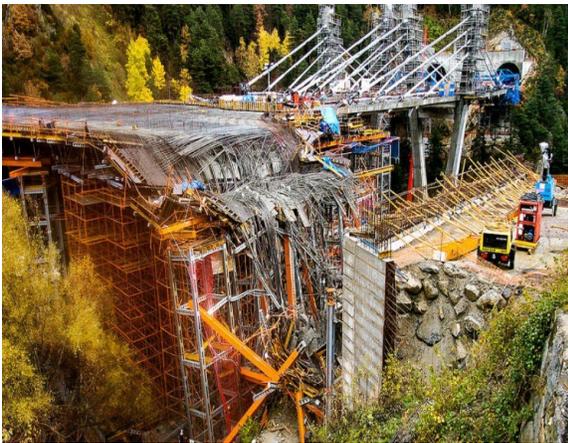
(c)

The Dos Valires Bridge, a twin-deck arch structure with partial cable-staying, collapsed on November 7, 2009, during the casting of its concrete deck. The temporary falsework supporting the formwork failed, sending wet concrete and several workers 15 meters into a valley below (Almeida, 2016). Five workers were killed and six were injured. Although an official cause was never conclusively published, reports suggest that misplacement of a traveling formwork segment may have triggered the collapse (Reina, 2009). This incident emphasizes the dangers of pouring concrete without a fully vetted and stable temporary support system.

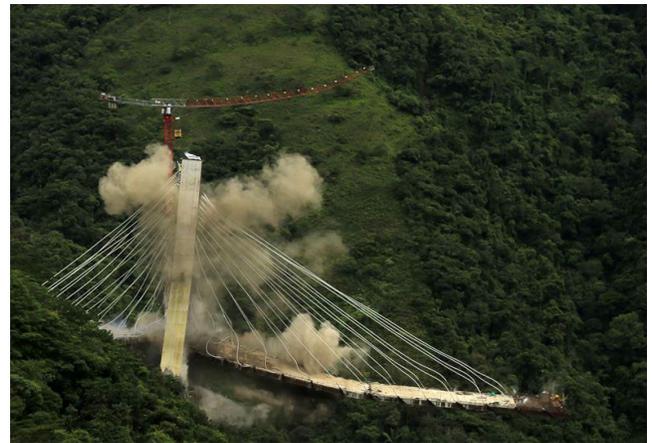
(d)

A catastrophic failure occurred during the construction of the Chirajara cable-stayed bridge on the Bogotá–Villavicencio highway. On January 15, 2018, one of the pylons (Tower B) failed mid-construction, causing the western half of the bridge to collapse and killing 10 workers (Georgakis et al., 2022). Forensic analysis later identified a critical design error: the strength contribution of a key diaphragm (transverse beam) in the tower was grossly overestimated, resulting in brittle failure under construction loads. The remaining tower was deemed unsafe and subsequently demolished. This case underlines the importance of independent design verification and close monitoring of temporary construction stages (Murphy et al., 2025).

Another lesson centers on the need for designs to fully account for construction-stage loading. The collapse of the Chirajara Bridge highlights that even structurally sound final designs can fail if temporary load paths are not evaluated correctly. In this case, a misjudgment in the behavior of a critical transverse beam under temporary conditions led to brittle failure. This underscores the necessity for independent design reviews and staged analysis particularly for hybrid or non-redundant systems to ensure all phases of construction are structurally stable.

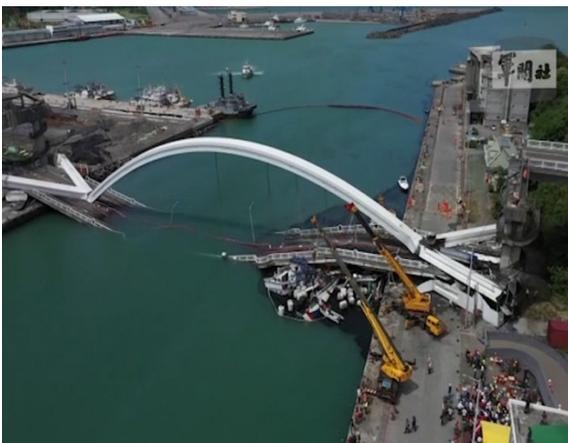
(e)

Nanfang'ao Bridge, a single-span steel tied-arch bridge over a fishing harbor, collapsed on October 1, 2019, 21 years after it opened. The failure began with the snapping of a corroded hanger cable, which caused a chain-reaction collapse as other cables failed in succession (Fan et al., 2025). A subsequent investigation found advanced corrosion in the hanger system, exacerbated by inadequate inspection and maintenance. The bridge lacked redundancy in its hanger configuration, relying on a single row of suspenders without backup systems. Six people were killed in the collapse, and the incident has since driven reforms in Taiwan's bridge inspection protocols, especially for coastal structures (Tseng et al., 2023).

Long-term safety also depends on robust maintenance and system redundancy, as illustrated by the Nanfang’ao Bridge. The progressive collapse triggered by the failure of a corroded hanger cable revealed both the absence of adequate inspection regimes and a lack of redundant load paths. Regular inspection, proper detailing for corrosion protection, and the use of backup cable or hanger systems are non-negotiable requirements in modern arch bridge design, particularly in coastal or harsh environments.

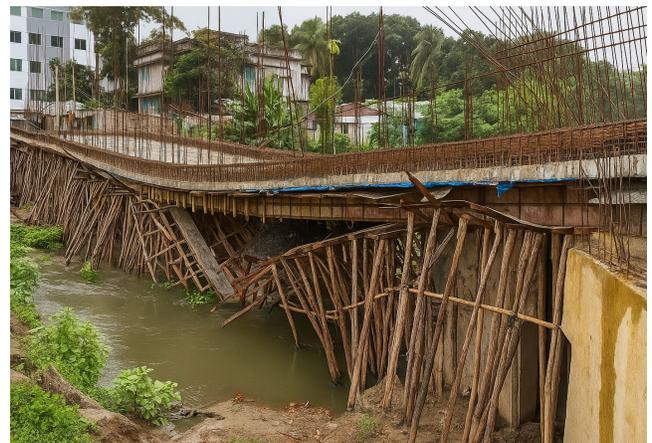
(f)

In 2022, an under-construction concrete arch bridge in the Tangail district of Bangladesh collapsed, though fortunately without casualties. The failure was attributed to improper design of the temporary works and the use of unfit, low-cost materials like bamboo and untreated lumber in scaffolding. Additionally, no proper curing time was maintained before loading. While the collapse caused no injuries, it served as a wake-up call in the region and underscored the pressing need for adopting standard construction methodologies, even in low-budget infrastructure projects.

Finally, the Tangail bridge incident in Bangladesh serves as a cautionary example of how improper sequencing and material misuse even on small-scale projects can result in failure. Project documentations often overlook the temporary work, and the design and implementation of temporary work are only on contractor’s plan and capacity, unapproved substitutions, use of low-quality materials like untreated timber, and failure to follow curing protocols all weaken the structure long before it is operational. Proper methodology, as outlined in engineering standards and project specifications, must be followed regardless of project budget or scale.

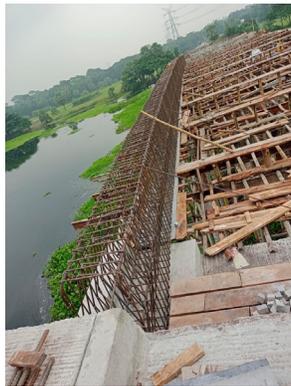
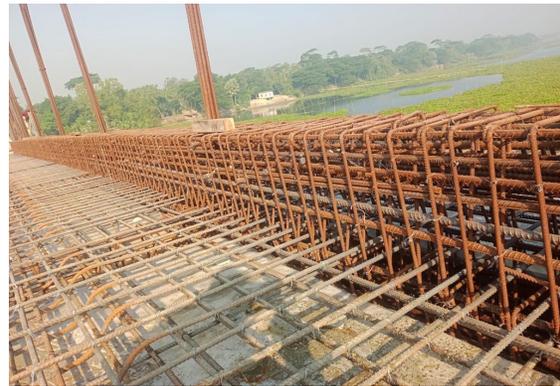
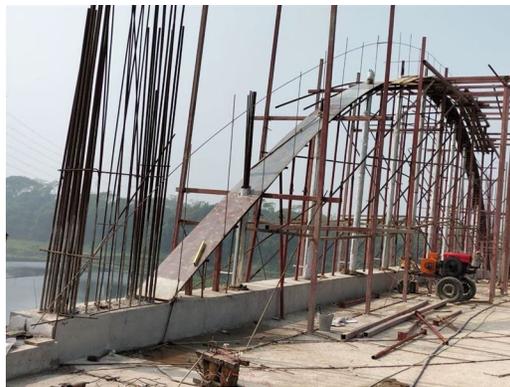
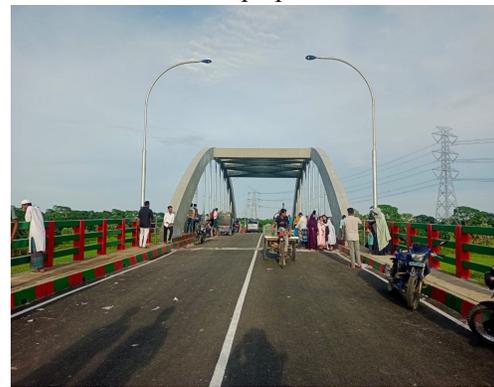
To validate the understanding of arch load transfer mechanics and the lessons learned from previous failures, a 35-meter tied arch bridge was constructed at Shibchar Pourashava (Shibchar Upazila, Madaripur District) under the authority of the Local Government Engineering Department (LGED), Bangladesh. Completed in 2022, the project strictly adhered to the detailed construction methodology and scaffolding removal sequence outlined in this study (Mostafiz, 2022). Upon completion, the bridge was successfully commissioned for service, exhibiting no signs of structural distress or construction-related defects, thereby verifying the efficacy of the proposed methodology (Figure 7).

(a) 1st Stage Scaffolding

(b) Tie beam, cross girder and deck casting preparation

(c) 2nd stage scaffolding

(d) After removal, the bridge in service

Figure 7. Successful completion of arch bridge construction (Mostafiz, 2023)
