# **Wayfinding as a Patient-Centered Safety System: A Human Factors Case Study of Escalator Use and Fall Risk in Healthcare**

Falls are a persistent patient safety concern throughout healthcare facilities, yet prevention efforts often focus on monitored clinical settings rather than the complex environments patients navigate before and after outpatient care. This case study examines escalator use and fall risk in a large academic medical center through a human factors assessment of wayfinding, signage, and environmental design. The objective was to identify opportunities to reduce unsafe navigation decisions by improving access to safer vertical transport options. A human factors safety engineer conducted an observational environmental audit across interconnected buildings, parking structures, and patient access pathways. The assessment qualitatively evaluated sign visibility, decision points, route complexity, and anticipated user behavior. Findings indicate that escalators were frequently more visible and convenient than elevators, while elevator routes were less prominent, inconsistently labeled, and often located along less intuitive pathways. These conditions contribute to na

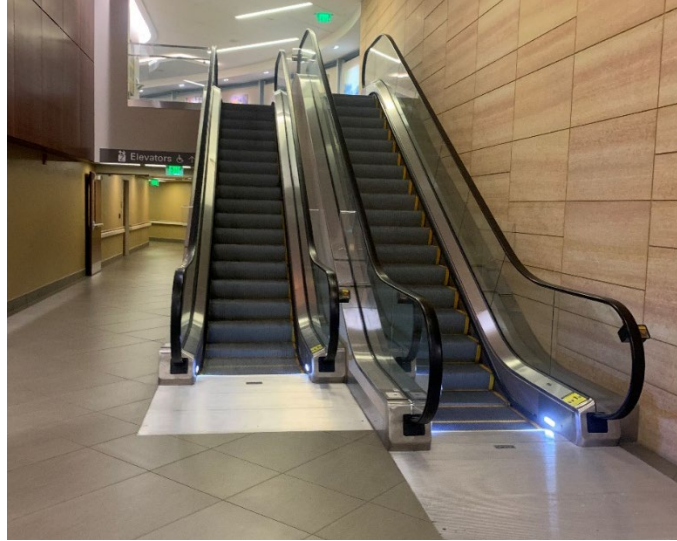
Figure 1. Escalators and elevator hallway at a decision point between building 1 to building 2.

Based on the walkthrough and incident descriptions, clear navigation challenges were identified between Building 1 and Building 2 and within Building 2. In Building 1, the sign for Elevator Z is not highly visible. Figure 1 shows the escalators leading from Building 1 to Building 2, with limited visibility of signs as users approach the elevators. This view shows the escalator as the most visually prominent vertical transportation option, while Elevator Z is less visible and located off to the side. The image illustrates how limited elevator visibility may influence patients and visitors to select the escalator before recognizing the elevator option. The elevator sign is partially hidden behind and to the left of the escalator, and the elevator label “Z” is not visible until users reach the elevator. The elevators are located to the left of the escalators through a small hallway. Once users enter the hallway to Elevator Z, some signage is present. However, signage at Elevator Z, both outside and inside on floor G, does not provide enough information to confirm that users can access their intended destination.

| Identified Barrier | Human Factors Implication | Potential Safety Impact | Proposed Intervention |
|---|---|---|---|
| Elevators are less visible than adjacent escalators at key decision points. | Users tend to choose the most visible and immediately available option. | Increased use of escalators by individuals who may be better served by elevators. | Add prominent elevator signs before decision points and improve line-of-sight visibility to elevators. |

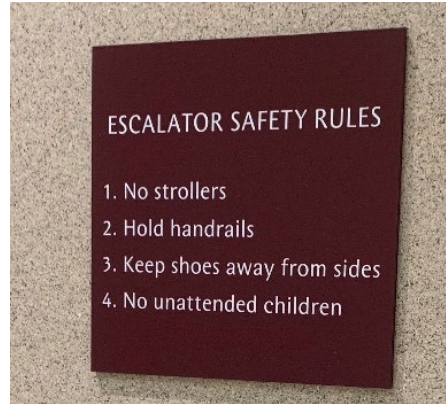
Figure 3. Limited escalator safety signage in Building 2.

In Building 2, the architectural design includes an open corridor connecting Buildings 2 and 3, with elevators in each building. An elevator is located at each end of the corridor, and two pairs of escalators span two vertical floors along the corridor. In Building 2, escalator signage was limited along the pathway connecting to building 3. A small safety sign (Figure 3) provided limited information and did not include warnings or instructions for individuals with mobility challenges. This image shows existing escalator signage in Building 2, which provides limited safety information and does not clearly direct patients or visitors with mobility challenges to nearby elevator alternatives. The figure supports the recommendation for more visible and human-centered safety messaging at escalator entrances.

| Escalator approaches contain limited safety messaging. | Users may not recognize escalator use as a potential mobility-related hazard. | Increased risk for falls among patients with mobility limitations, fatigue, or assistive devices. | Add human-centered safety messaging and elevator alternatives at escalator entrances. |

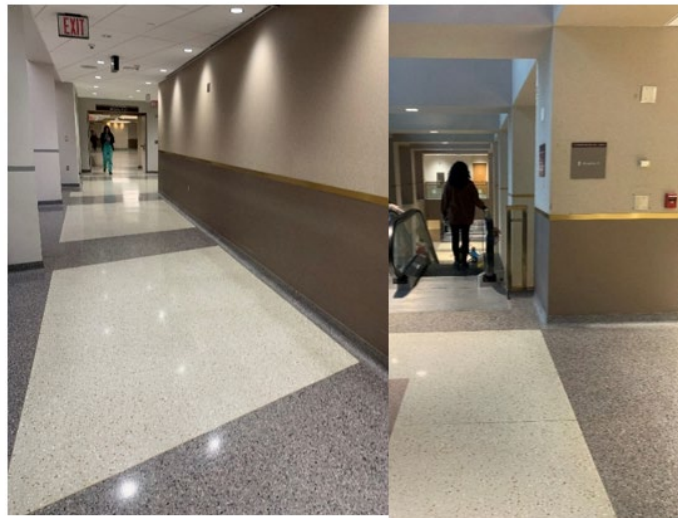
Figure 4. Navigation options from the Heart and Vascular Clinic in Building 2

One location-specific environmental condition was identified for patients exiting the Heart and Vascular Clinic in Building 2. Signage is limited, and directions are unclear. When exiting the clinic, the escalator to level 3 is directly ahead. To the left (Figure 4, left), a long hallway leads toward an elevator in Building 3 with no clear elevator view. To the right (Figure 4, right), the hallway view toward the escalators, which are more visually prominent than nearby elevator routes. The hallway to the elevators in Building 2 is long and partially hidden to the right of the escalator entrance (not visible to the right of Figure 4). With long hallways and limited signage, users may choose the closest and clearest option. In this case, the clearest option is the escalator. Patients visiting the Heart and Vascular Clinic may have mobility challenges and may face wayfinding uncertainty during navigation.

| Patients exiting a Heart and Vascular Clinic encounter unclear vertical navigation options. | The most visually salient route is the escalator rather than the elevator. | Higher-risk route selection among patients who may have cardiovascular or mobility concerns. | Install directional signage immediately outside the clinic indicating elevator locations and destinations. Include check-out navigation guidance. |
