Management of Health and Safety Risk Associated with Excavation Cave-in

The most dangerous construction tasks are trenching and excavation related works, resulting in accidents among construction employees. The study assessed health and safety risk associated with excavation cave-in. Delphi method of data collection was employed in the administration of questionnaires, among six academics and seven construction professionals in Cape Coast Metropolis. Findings from the study show that adequate measures were put in place by the contractors to minimize cave-in. The employed safety measures with high response rate are: heavy equipment should be kept away from trench edges, appropriate training on shoring should be provided to all workers and trenches should be inspected on regular basis, and at the start and end of each shift. While the employed safety measures with low response rate are attributed to: trench evaluation should be rigorous when there was heavy down pour and shoring of trenches should be carried out by specialists. Further findings indicate that all the construction sites applied one or two of the installation preventive systems, namely shoring and sloping the ground. T

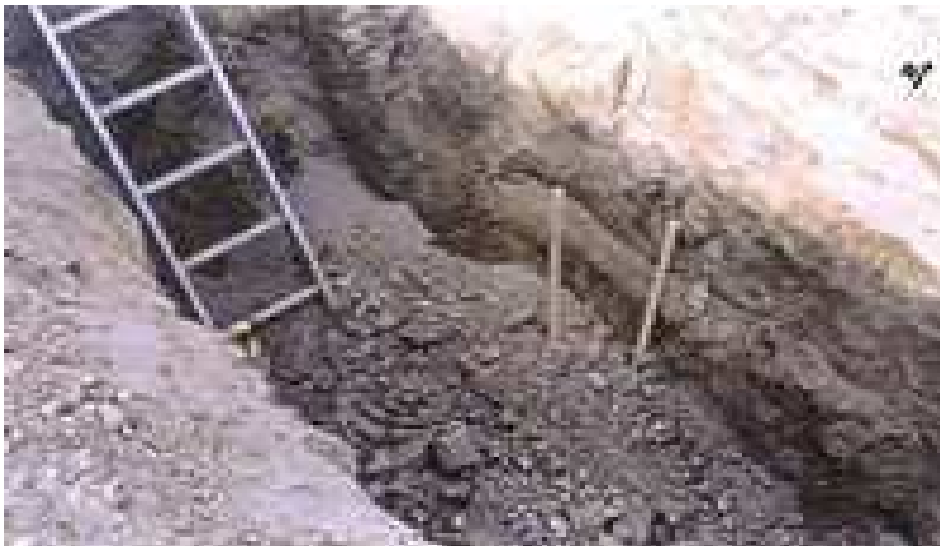
Figure 1: Excavation exercise
Source: Development of Draft Construction Safety Standards for Excavations (n.d.)

Information from the U.S. Bureau of Labor Statistics (BLS) data show that Sixty-eight percent of trenching or excavation cave-ins fatalities occurred in companies with fewer than 50 workers. Forty-six percent of the deaths occurred in small companies with 10 or fewer workers. BLS reports indicates that regulations and consensus standards which describes engineering controls, protective equipment, and safe work practices should be employed during excavation works, in a situation similar to Fig. 1 to minimize hazards for workers during trench work and excavations [2].

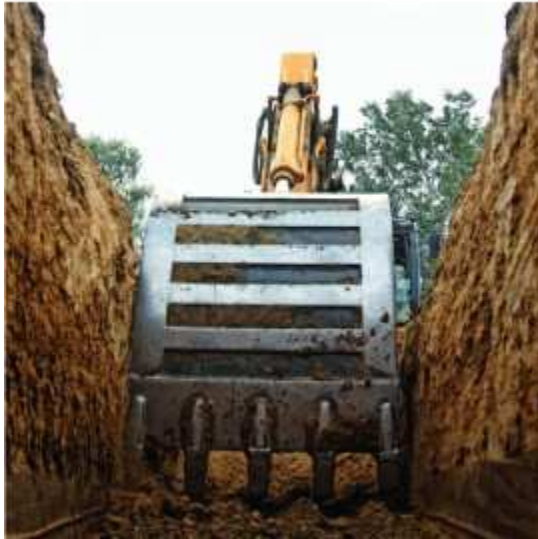
Figure 2: Excavation works with an excavator
Source: Gurley, 2012).

Cave-in has been found to be the greatest excavation risk. Employees are likely to be in danger in a situation in Fig.2, where the excavation depth is beyond 1.5m. Risk prevention associated with cave-ins should be carried out in such a way that all construction employees will be protected and it must be among the list of health and safety checklist of the safety officer. Hence, the use of an excavator to prevent any unforeseen. Adequate measures in the form of reinforcement of all trenches, relevant safety checks at regular intervals which should be in compliance with official health and safety guidelines should be put in place before any employee begins any excavation works [5,8]
